# SELLY PARK SOUTH FLOOD RISK MANAGEMENT SCHEME 2017-18

## Work is starting on the Environment Agency's £2.4 million flood risk management scheme in Selly Park South

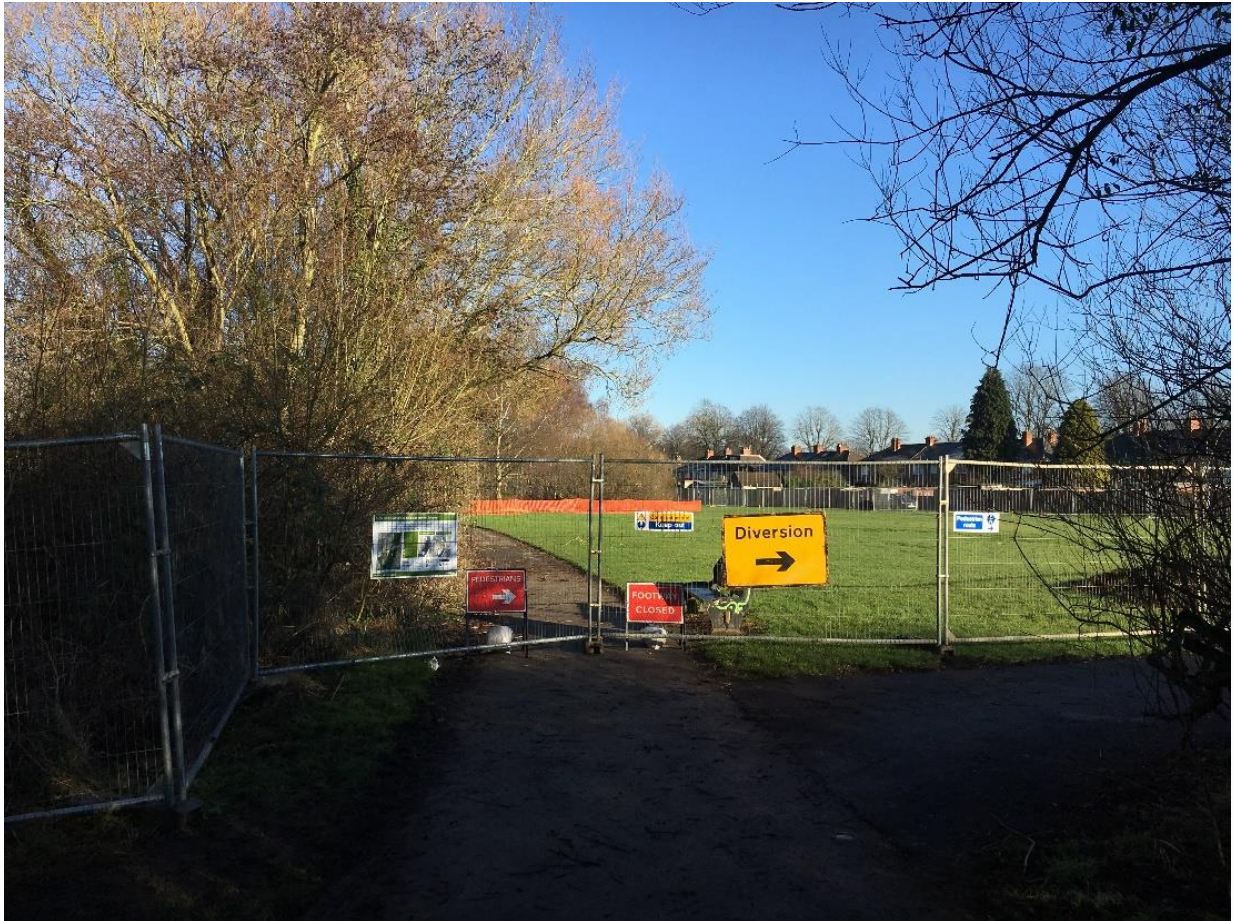
**PROGRESS REPORT Friday 20th January** - The area of parkland adjacent to Moor Green Lane and lying between the River Rea and Ashbrook Road has been fenced off while the construction of the scheme is taking place. A grass covered flood defence embankment (called a BUND) will be built around the edge of this area and will temporarily hold flood water for a few hours at the peak of a severe flood until the water naturally drains back to the river once river level falls. The Rea Valley cycle way and footpath has been temporarily diverted around the fenced off area.

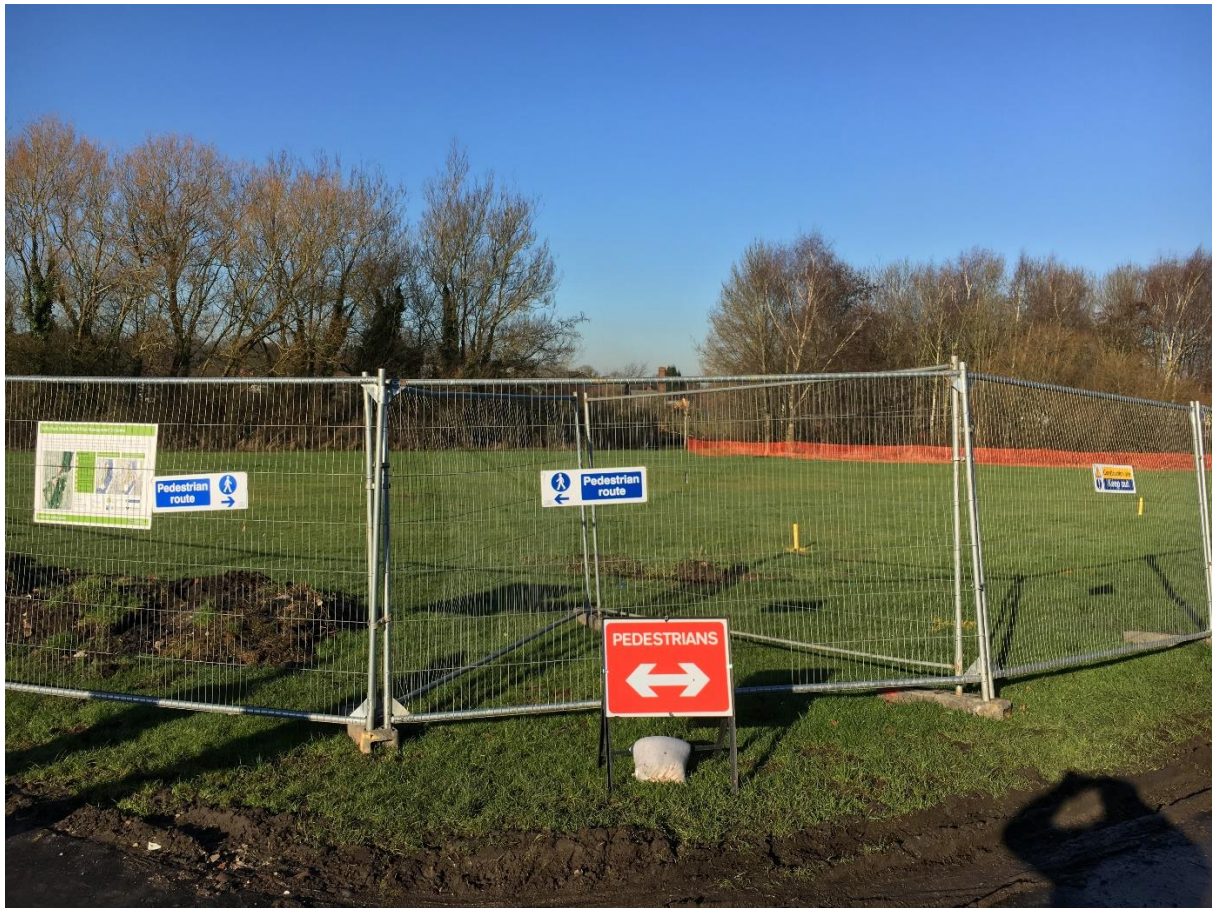
Preparation of the land within the fenced off area has continued. Low quality scrub vegetation has been cut down and scraped away and temporary plastic meshing fencing put around the more substantial clumps of trees which will remain. Marker stakes have been put in position indicating the line which the bund will follow.

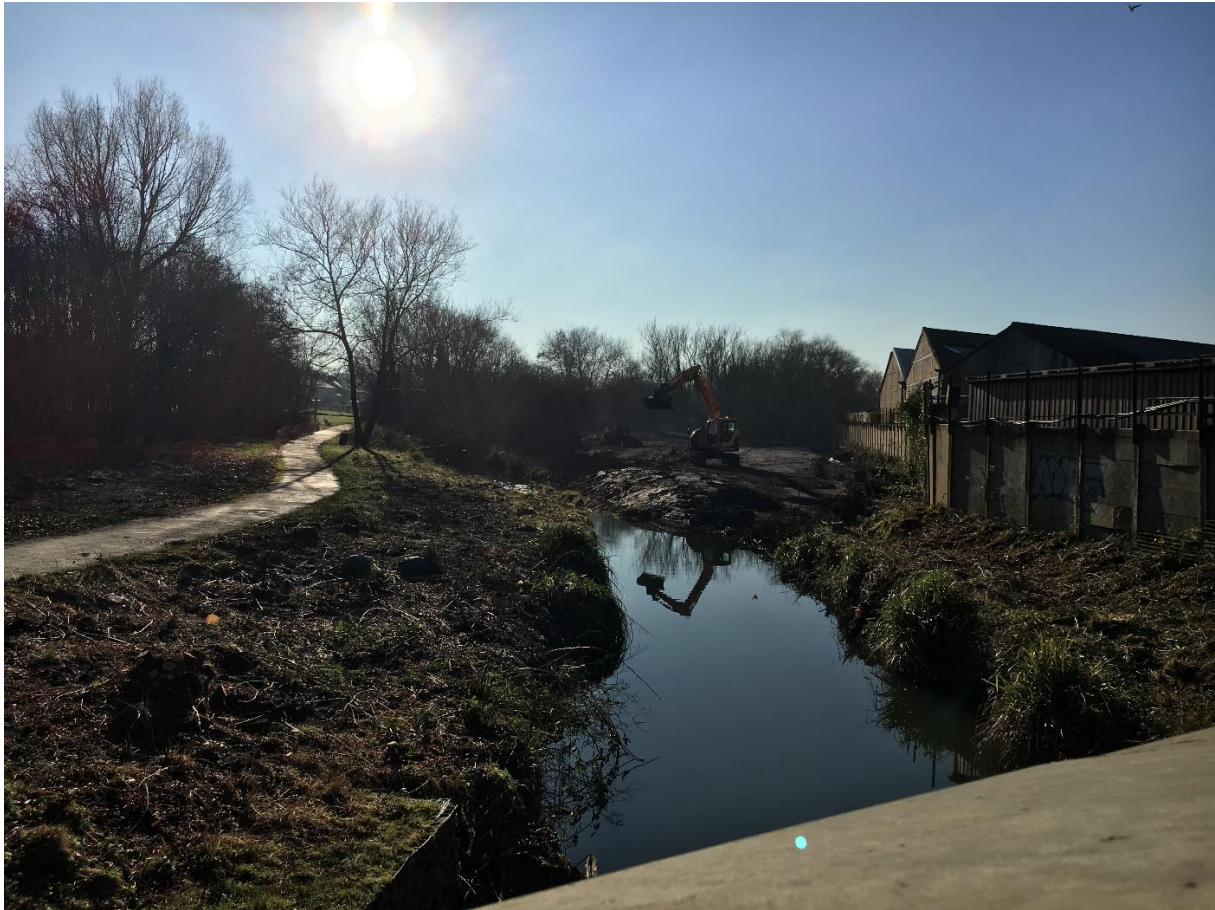
Meanwhile on the west bank vegetation has been cleared and a trackway built to allow machinery and materials to be brought in for the building of a flood defence wall which will prevent flood water from the river flowing through and around the factory unit to Dogpool Lane, Fashoda Road and Cecil Road.

Removal of vegetation and trees in particular has been kept to the absolute minimum necessary and the whole site underwent a detailed ecological survey to ensure the safeguarding of wildlife before the work started. New and indeed more diverse habitat will be created as part of the scheme.

In the coming weeks, work will begin on diverting the river as seen in this last image a short distance eastwards (to the left) to create a wider area of land on the western bank (on the right of the picture) for the building of the flood defence wall. Daytime traffic signals will be operative outside peak times to allow the creation of a temporary access route for heavy machinery across the west bank parkland. The parkland will be fully restored in the final stages of the project.

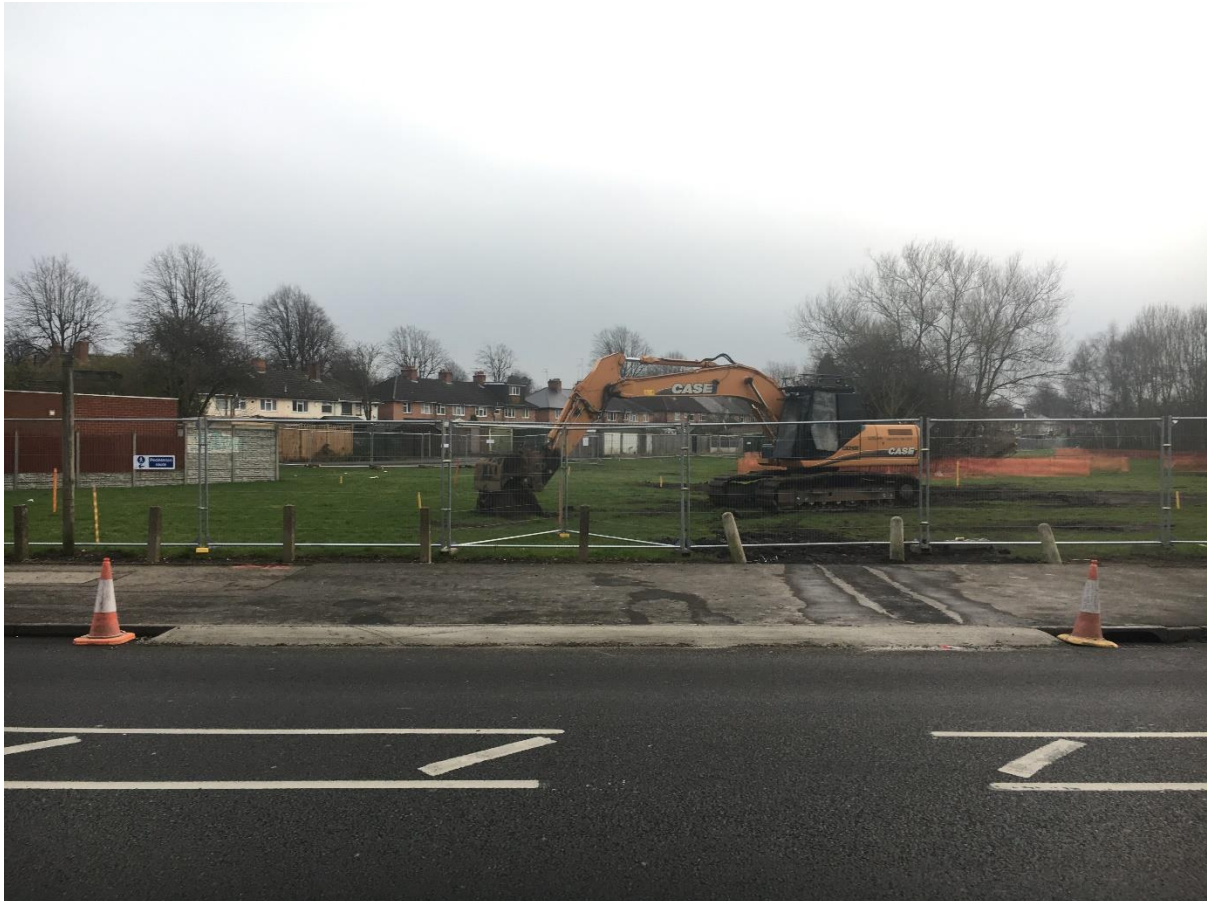
**PROGRESS REPORT Friday 27th January - Work ongoing during the THIRD week of January:** A dropped kerb in Moor Green Lane and other work has been carried out to allow the creation of a temporary access route for heavy machinery and materials across the west bank.

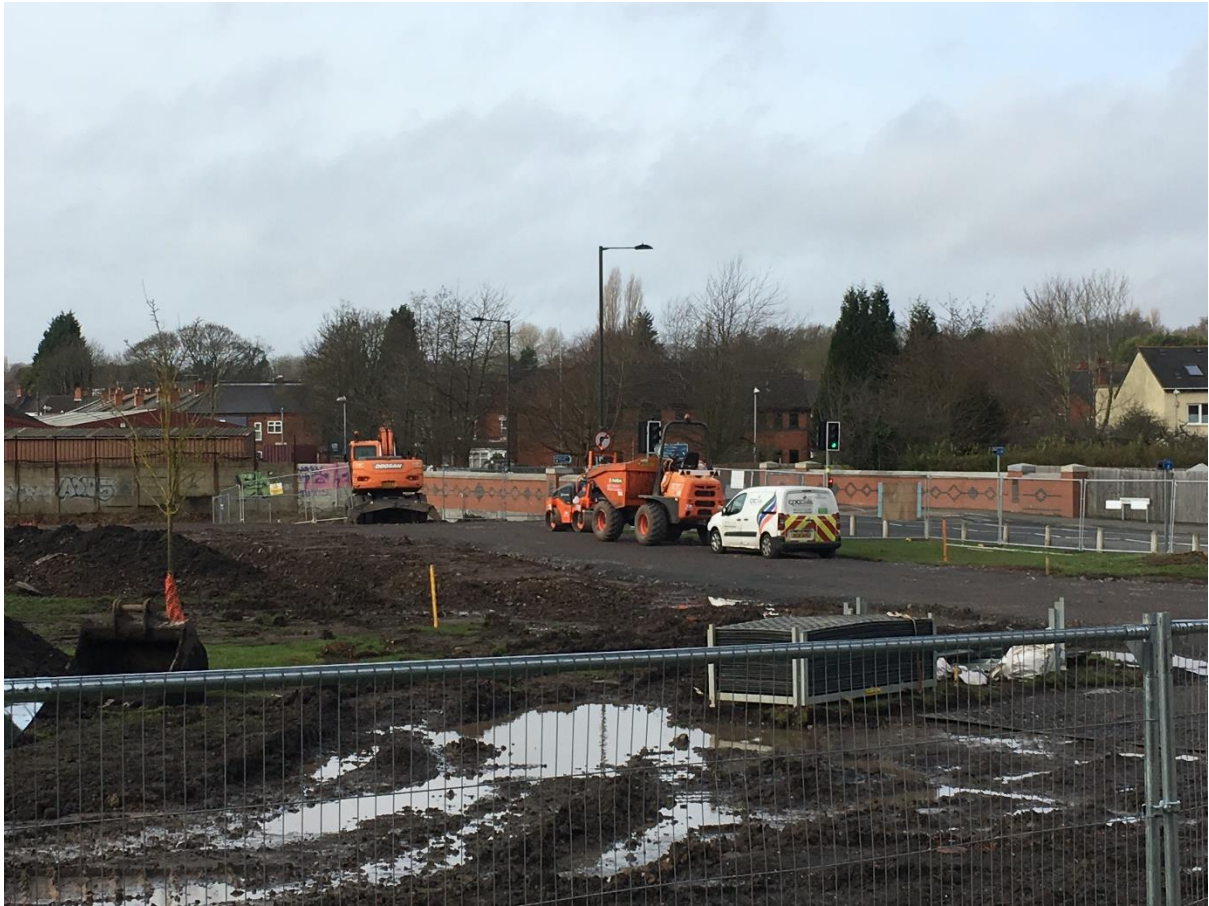
**PROGRESS REPORT Friday 3rd February - Work ongoing during the FIRST week of FEBRUARY:** Extensive preparation of the land on the east side of the river by heavy machinery for construction of the flood protection bund which will run alongside Moor Green Lane and along the back of Ashbrook Road. The parkland will be fully restored in the final stages of the project.

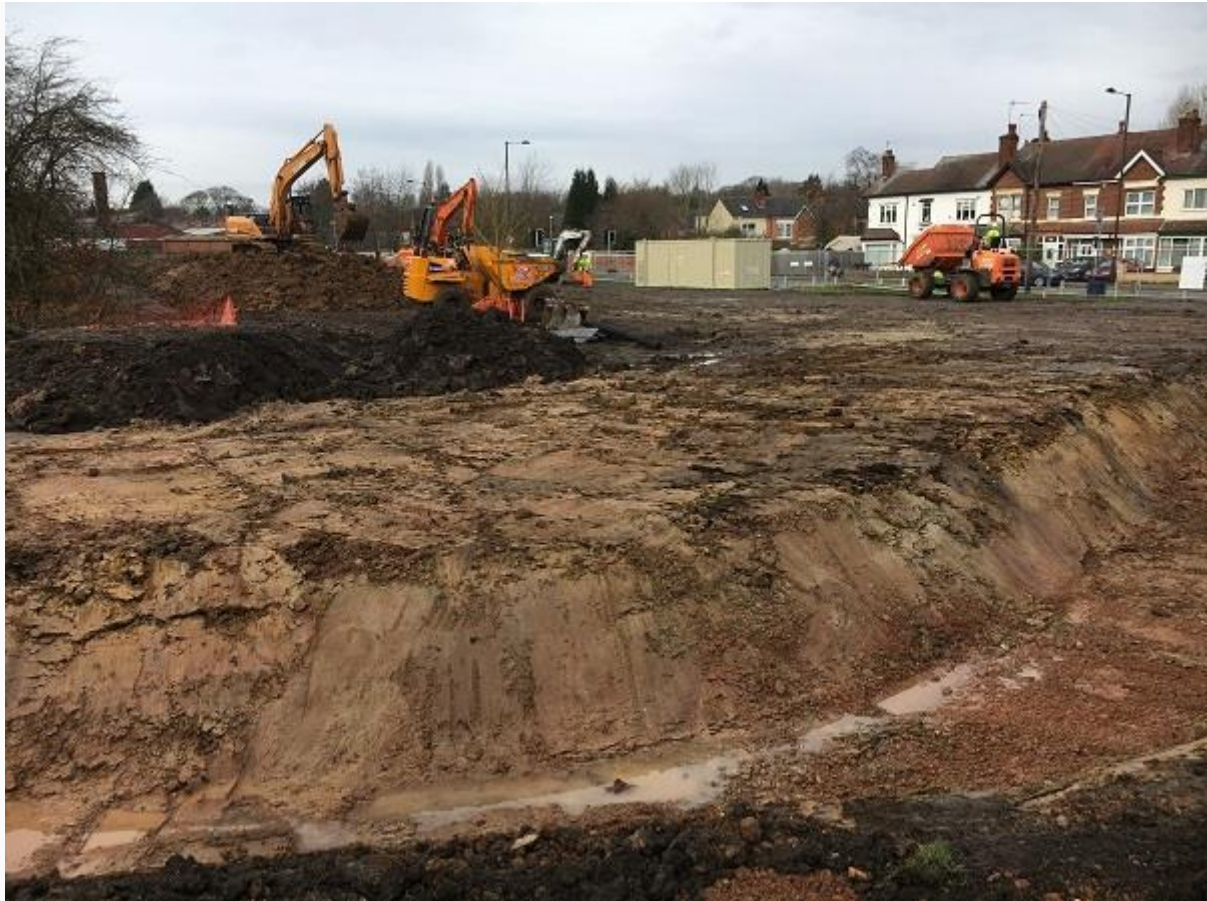
**PROGRESS REPORT Friday 17th February - Work ongoing during the THIRD week of FEBRUARY:** Extensive preparation of the land on the east side of the river by heavy machinery for construction of the flood protection bund which will run alongside Moor Green Lane and along the back of Ashbrook Road. The parkland will be fully restored in the final stages of the project.

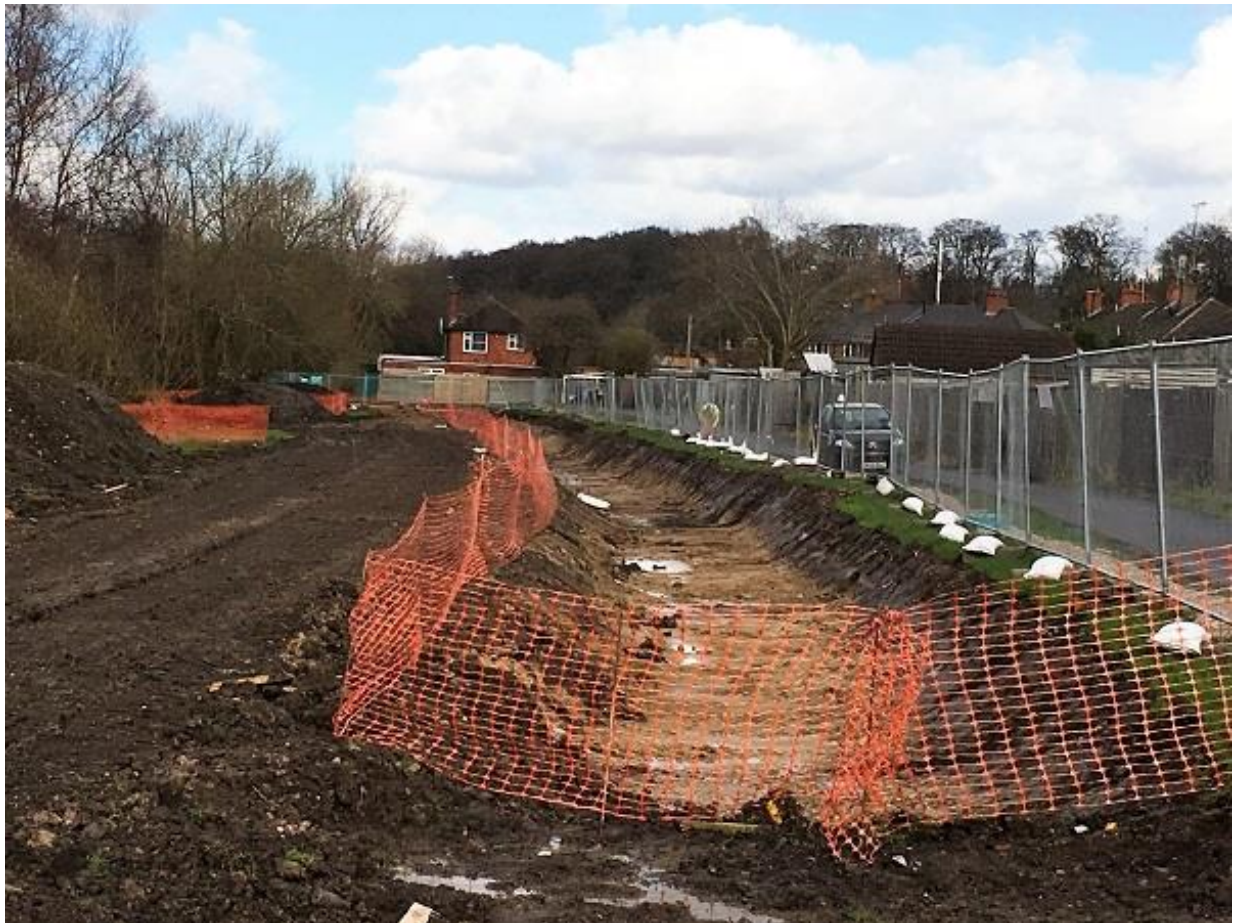
**PROGRESS REPORT Friday 24th February - Work ongoing during the FOURTH week of FEBRUARY:** On the edge of the parkland at the rear of Ashbrook Road a trench has been excavated ready for the construction of the flood protection bund (embankment). The trench will be filled and built up with clay which will form the impermeable core of the bund. Less dense soil will then be used to form the two side slopes and topping of the bund and the whole structure will be planted with grass. The parkland will be fully restored in the final stages of the project.

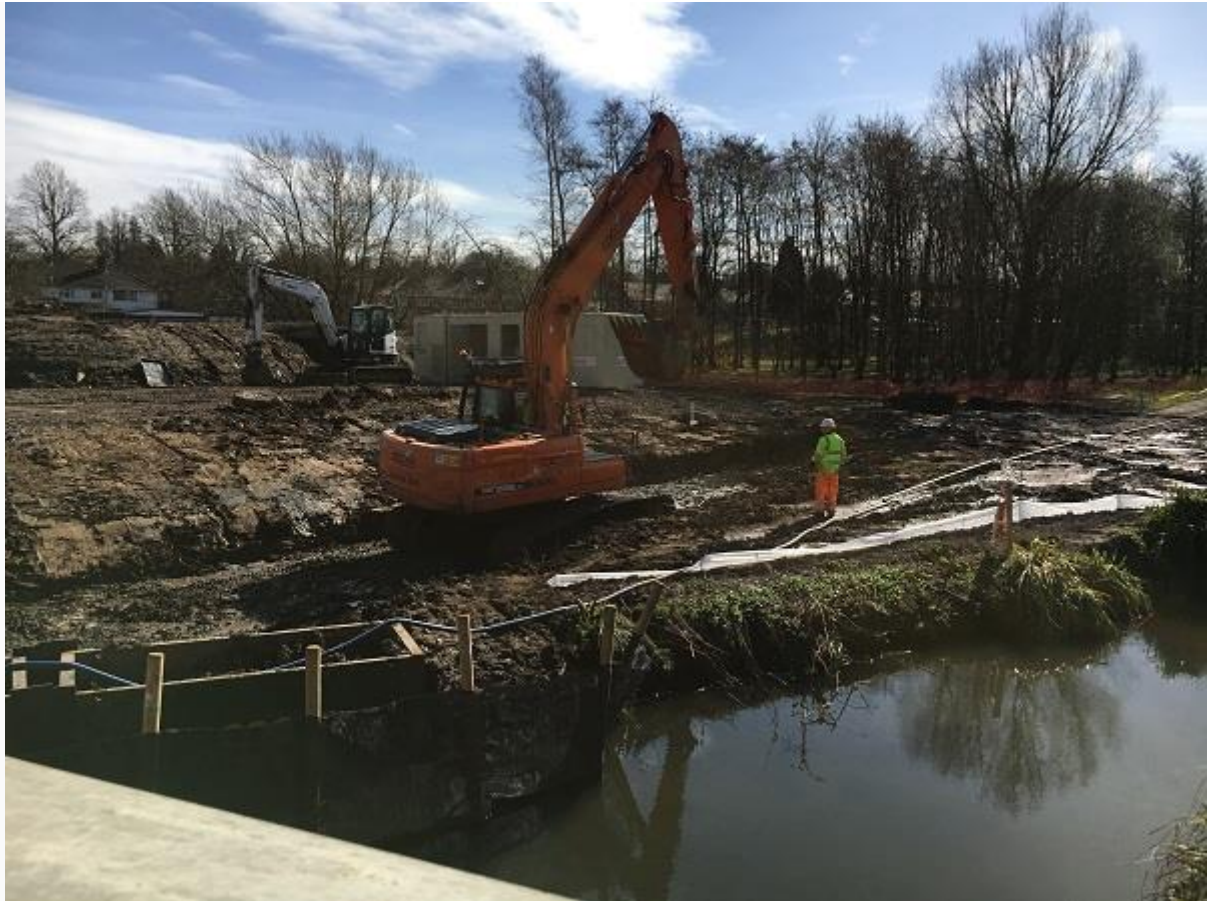
**PROGRESS REPORT Monday 13th March - Work ongoing during the SECOND and THIRD weeks of MARCH:** Work to realign the river channel immediately upstream from Dogpool Bridge has begun. The channel will be moved a few metres to the east to create sufficient working space on the western bank to allow heavy machinery in to build the flood defence wall adjacent to the factory. The realignment will also improve the flow dynamics of the river approaching the bridge. In the image below the mechanical digger is excavating a trench where the east bank reinforcements will be created.

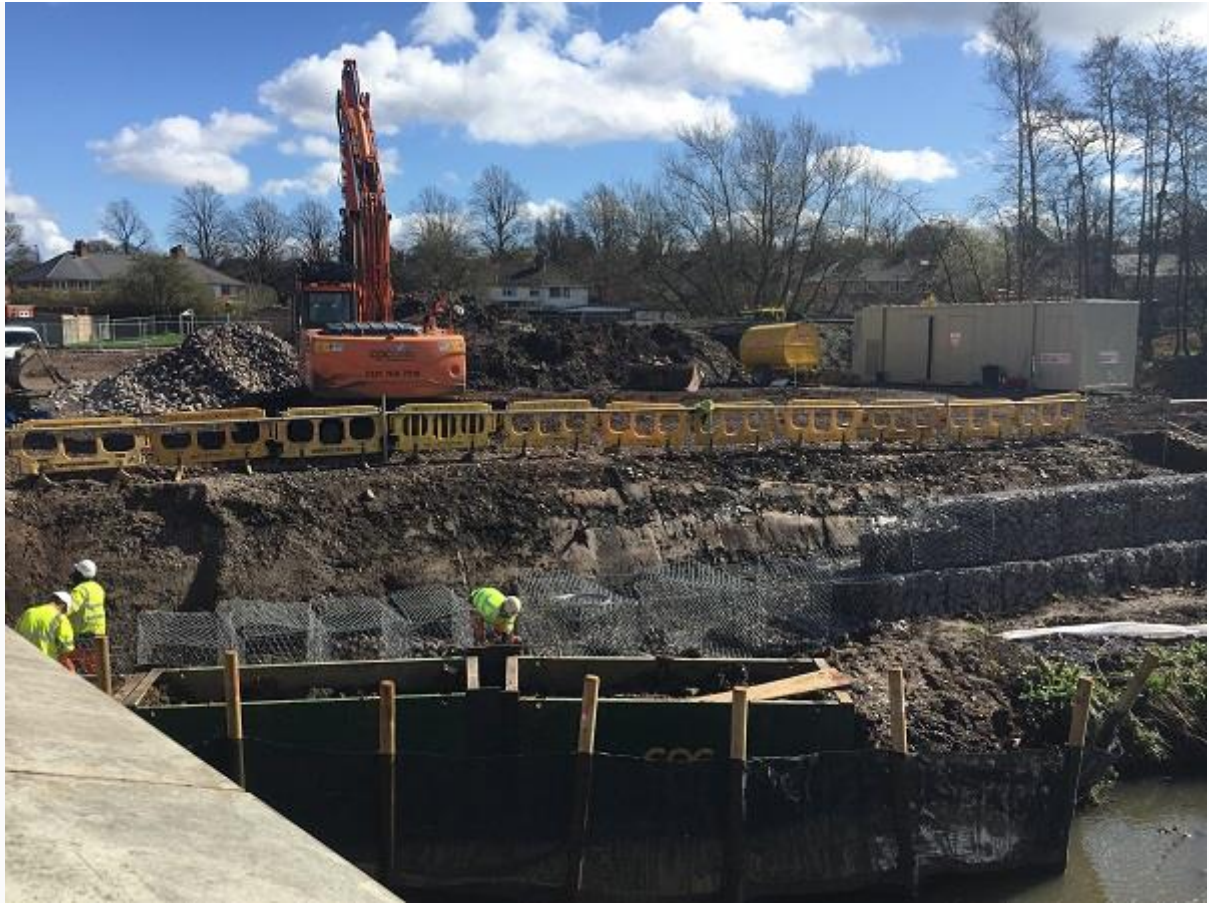
**PROGRESS REPORT Tuesday 21st March - Work ongoing during the FOURTH week of MARCH:** Work to realign the river channel immediately upstream from Dogpool Bridge is continuing. The channel will be moved a short distance to the east to create sufficient working space on the western bank to allow heavy machinery in to build the flood defence wall adjacent to the factory. The realignment will also improve the flow dynamics of the river approaching the bridge. In the image below the east bank reinforcements are be constructed using gabion baskets (steel baskets filled with rocks).

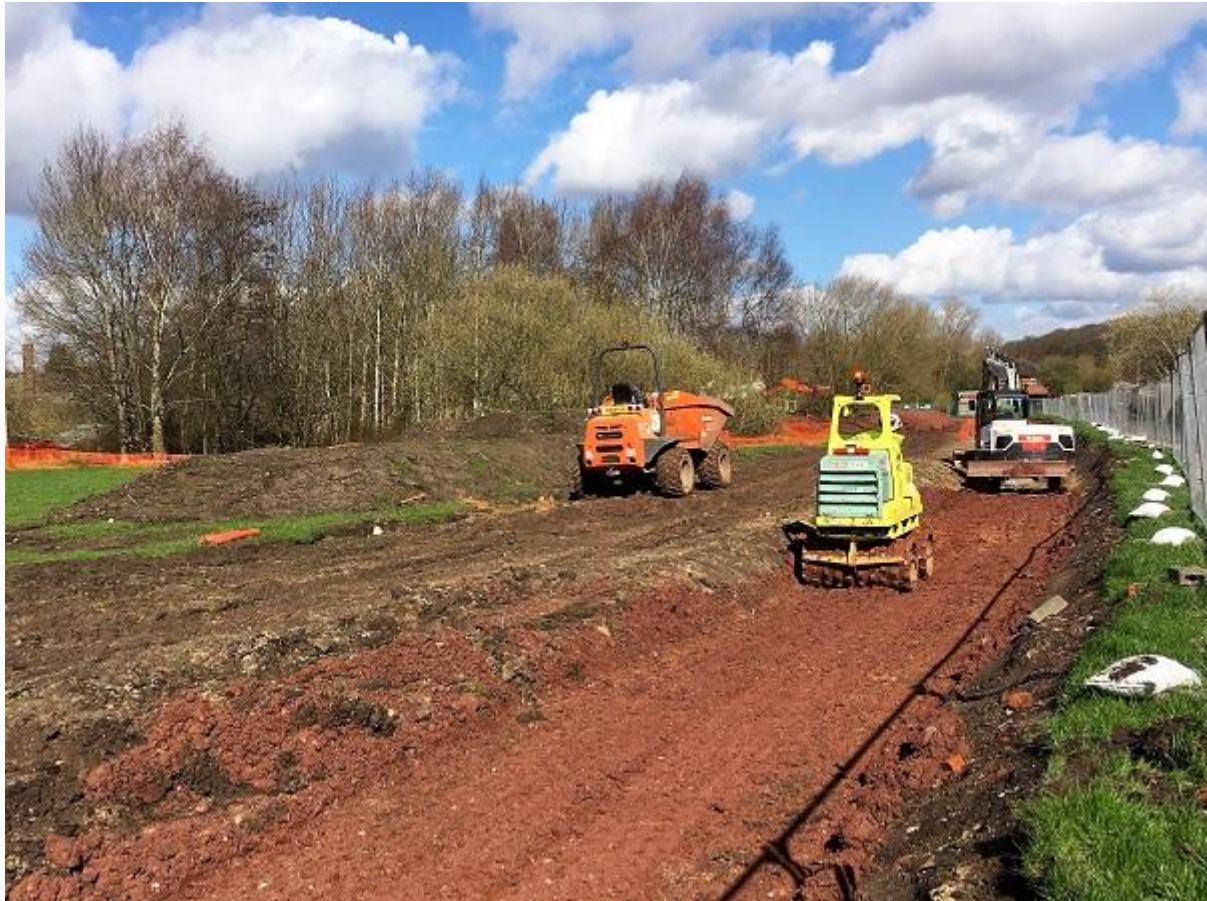
Meanwhile, running parallel behind the houses in Ashbrook Road the foundations for a bund (flood defence embankment) are being created by infilling the previously excavated trench with impermeable clay. This prevents water from forcing its way under the bund.

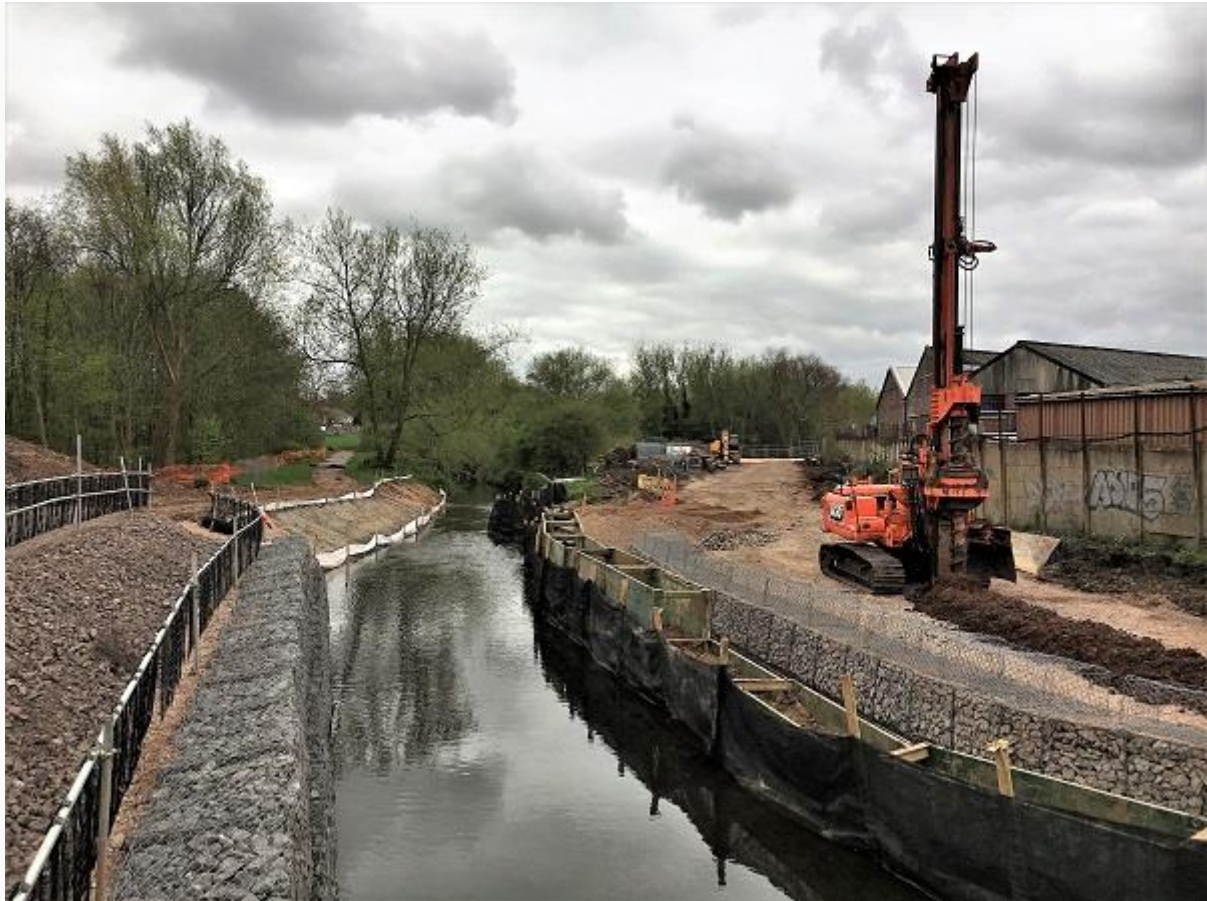
**PROGRESS REPORT Thursday 13th April - Work ongoing during the SECOND and THIRD week of APRIL:** Image below: Work is almost complete on diverting the channel of the River Rea just upstream from Dogpool Bridge. The channel has been moved a short distance to the east to allow access for heavy machinery to construct the flood defence wall on the western side of the river. The drilling machine is preparing the ground along the line where the concrete slabs of the wall will be piled into the ground.

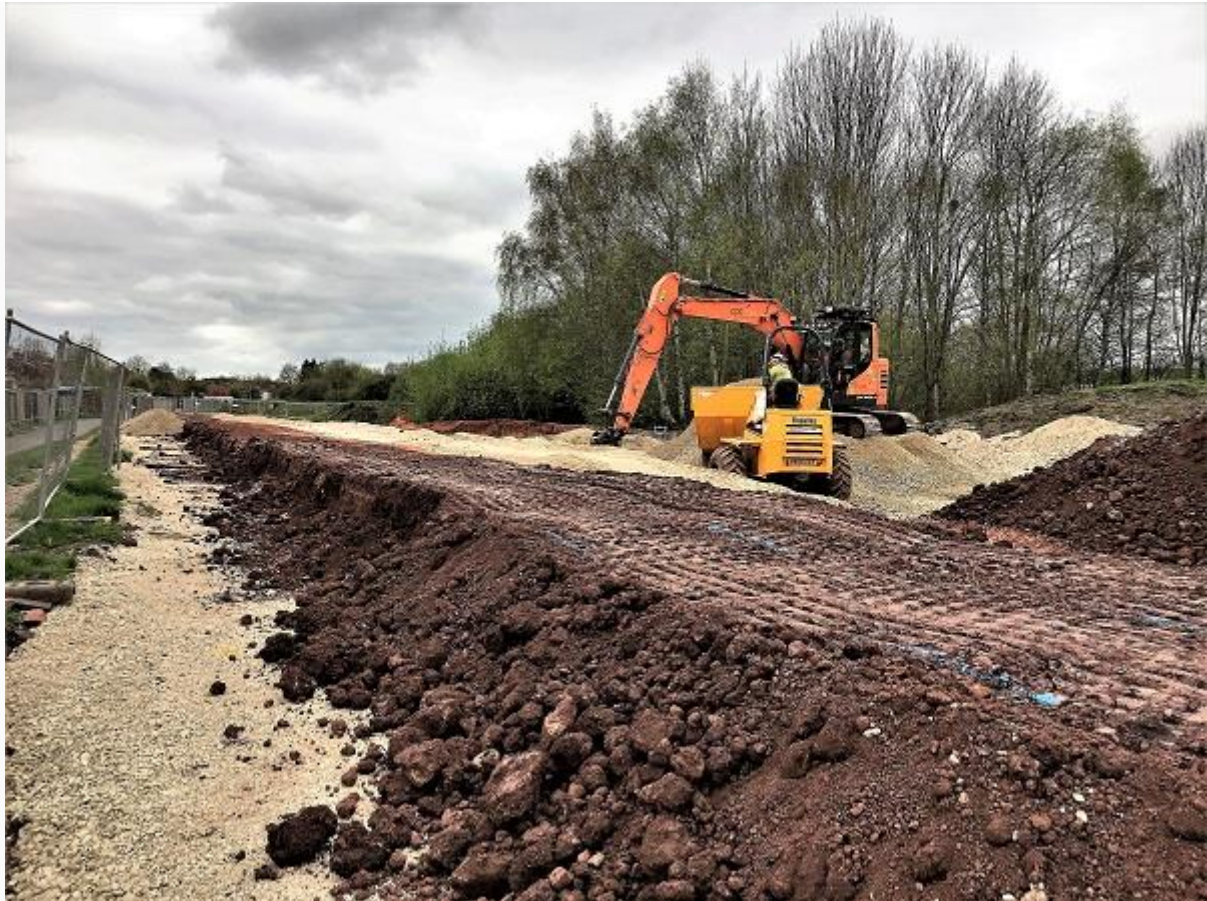
Image below: The eastern bund (flood defence embankment) is being constructed parallel with the rear of Ashbrook Road. The impermeable clay core of the bund is being laid on top of a clay foundation and will be packed down by a rolling machine. Sloping flanks will then be constructed on either side and the structure covered with topsoil and grassed over.

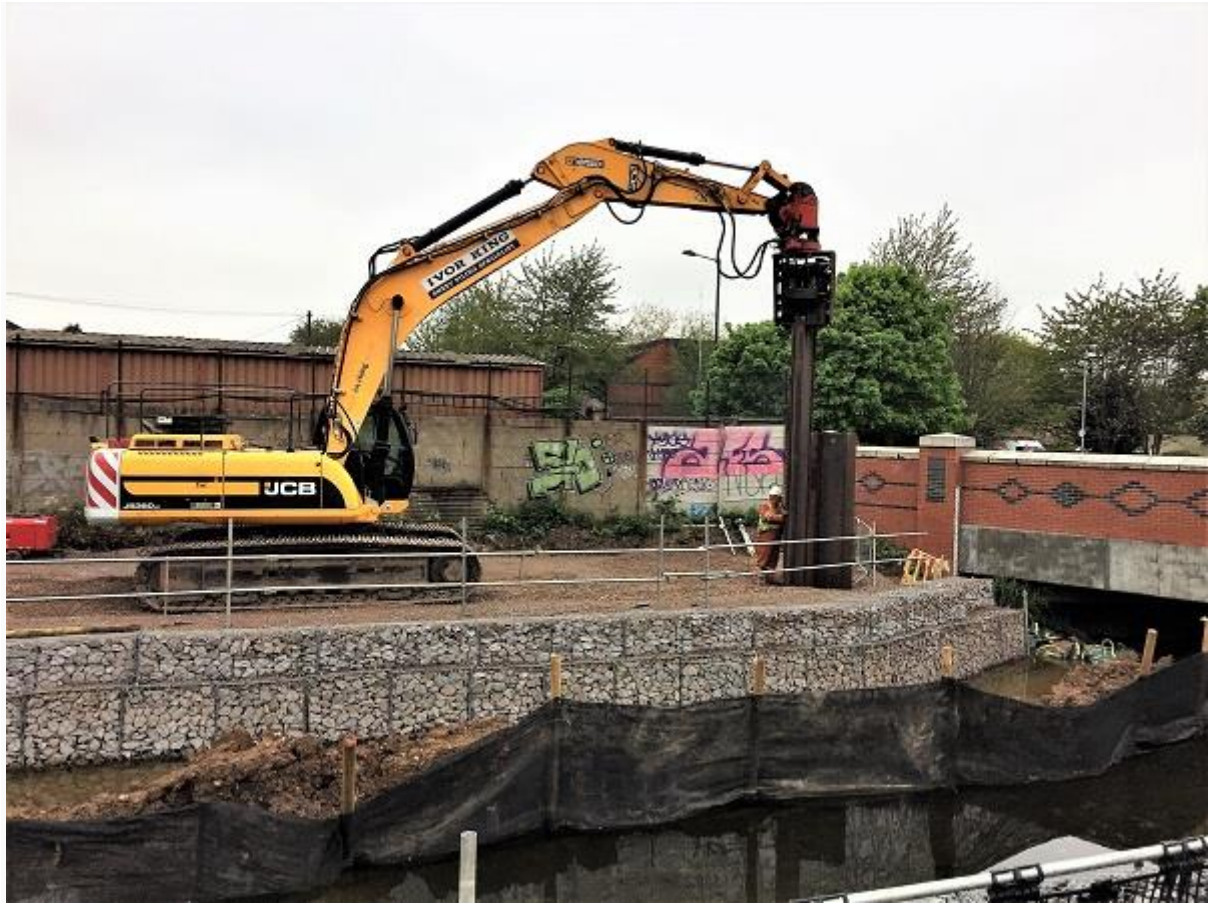
**PROGRESS REPORT Friday 28th April - Work ongoing during the LAST week of APRIL and the FIRST week of MAY:** Image below:  
Work is complete on diverting the channel of the River Rea just upstream from Dogpool Bridge. The channel has been moved a short distance to the east to allow access for heavy machinery to construct the flood defence wall on the western side of the river. Steel sheets are now being pile-driven into the ground and will be faced with brickwork and topped with a concrete cap to form the wall, very much like Dogpool Bridge.

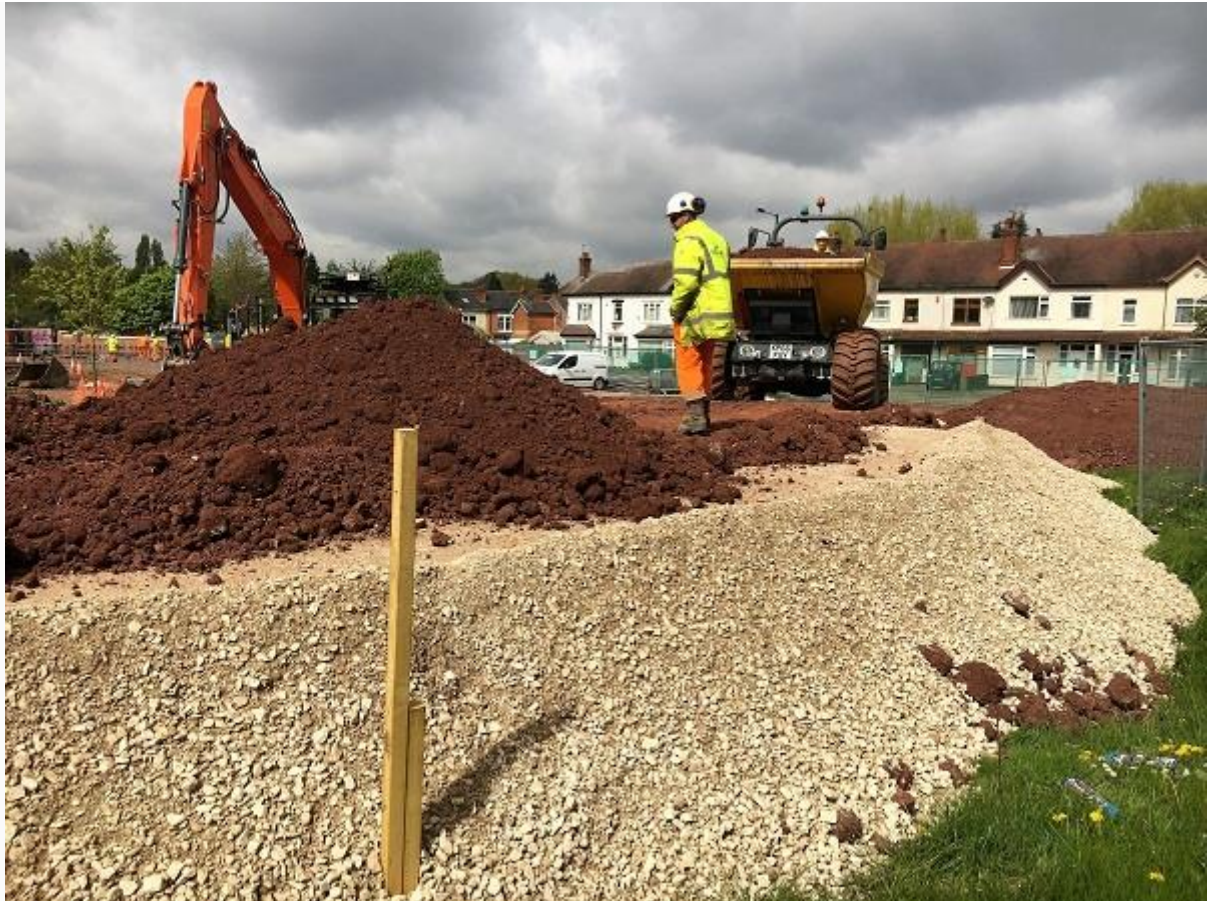
Image below: The eastern bund (flood defence embankment) is being constructed parallel with the rear of Ashbrook Road, then curving westwards to run parallel with Moor Green Lane as far as the bridge. The impermeable clay core of the bund is laid on top of a clay foundation and packed down by a rolling machine. Sloping flanks are then constructed on either side and the structure covered with topsoil and grassed over.

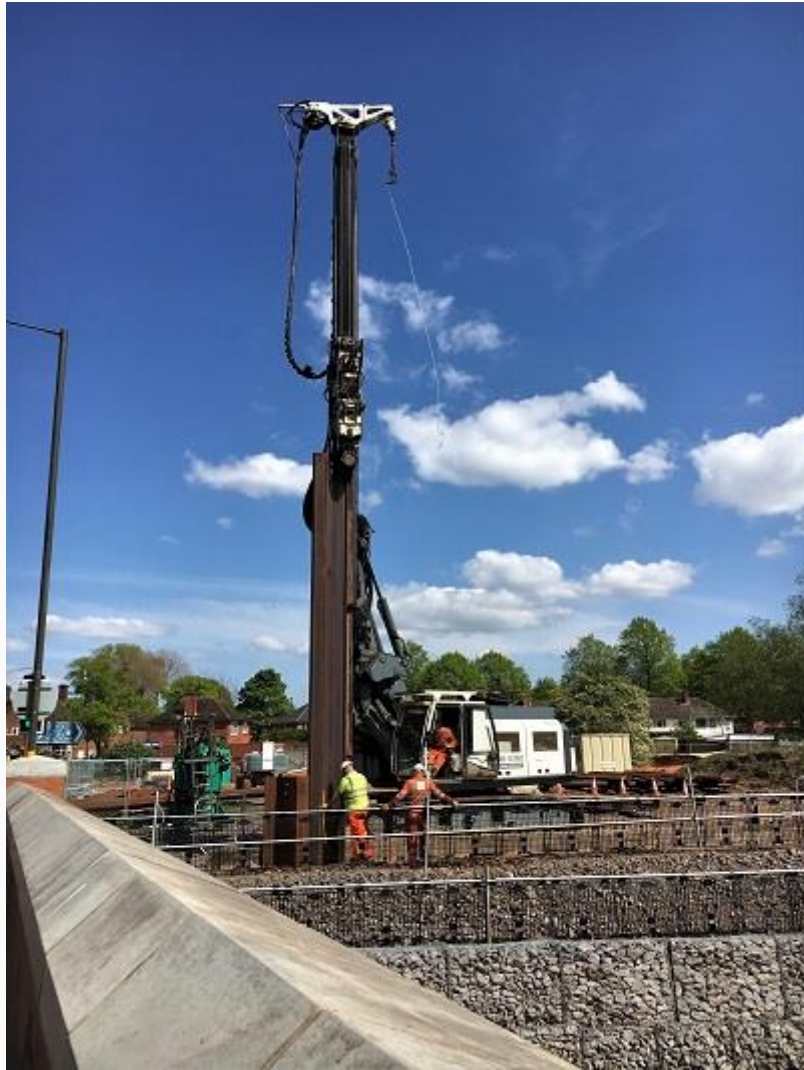
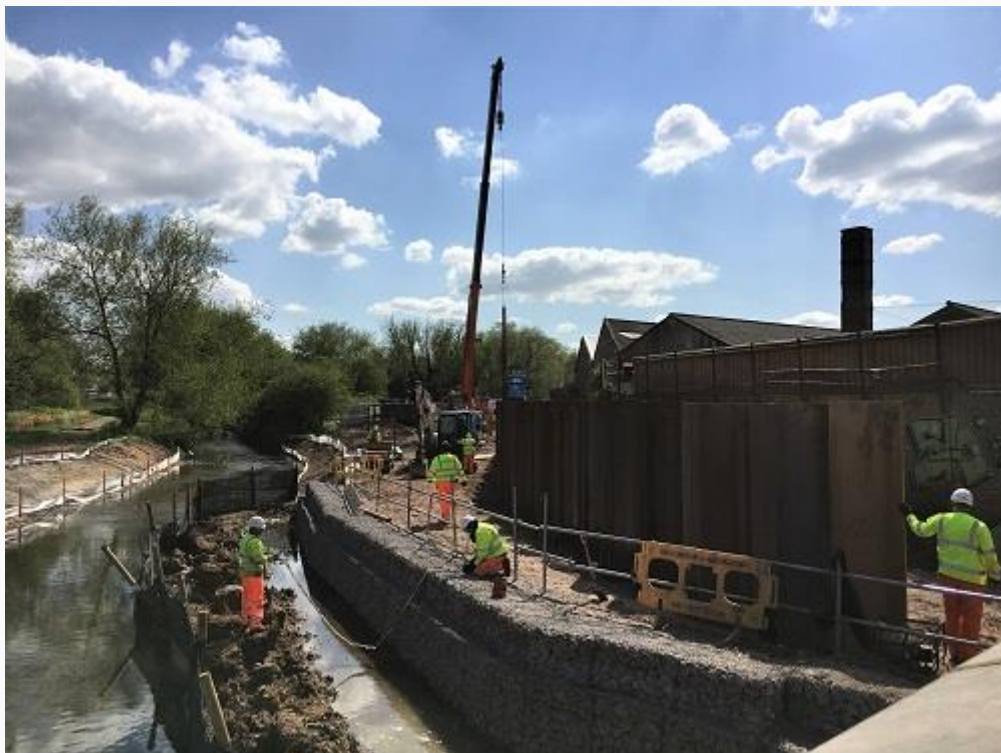
**PROGRESS REPORT Friday 5th May - Work ongoing during the FIRST HALF of MAY:** Images below: The river channel just upstream of Dogpool Bridge has been moved a short distance to the east to allow access for heavy machinery to construct the flood defence wall on the western side of the river. Steel sheeting is being pile-driven into the ground to form the core of the wall which will be brick clad and have a concrete capping similar to the bridge.

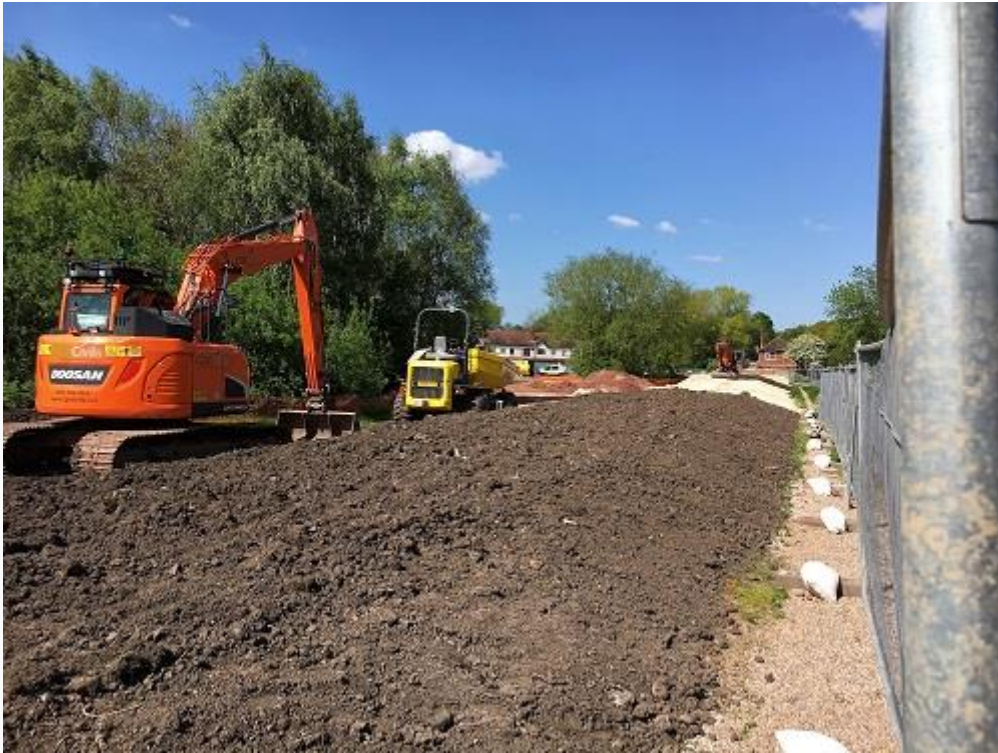
Image below: The eastern bund (flood defence embankment) is being constructed parallel with the rear of Ashbrook Road. An impermeable clay core has been laid on top of a clay foundation. Sloping flanks of aggregate have been laid either side and the structure is being covered with soil ready for grassing. The bund will be extended then to run parallel with Moor Green Lane.

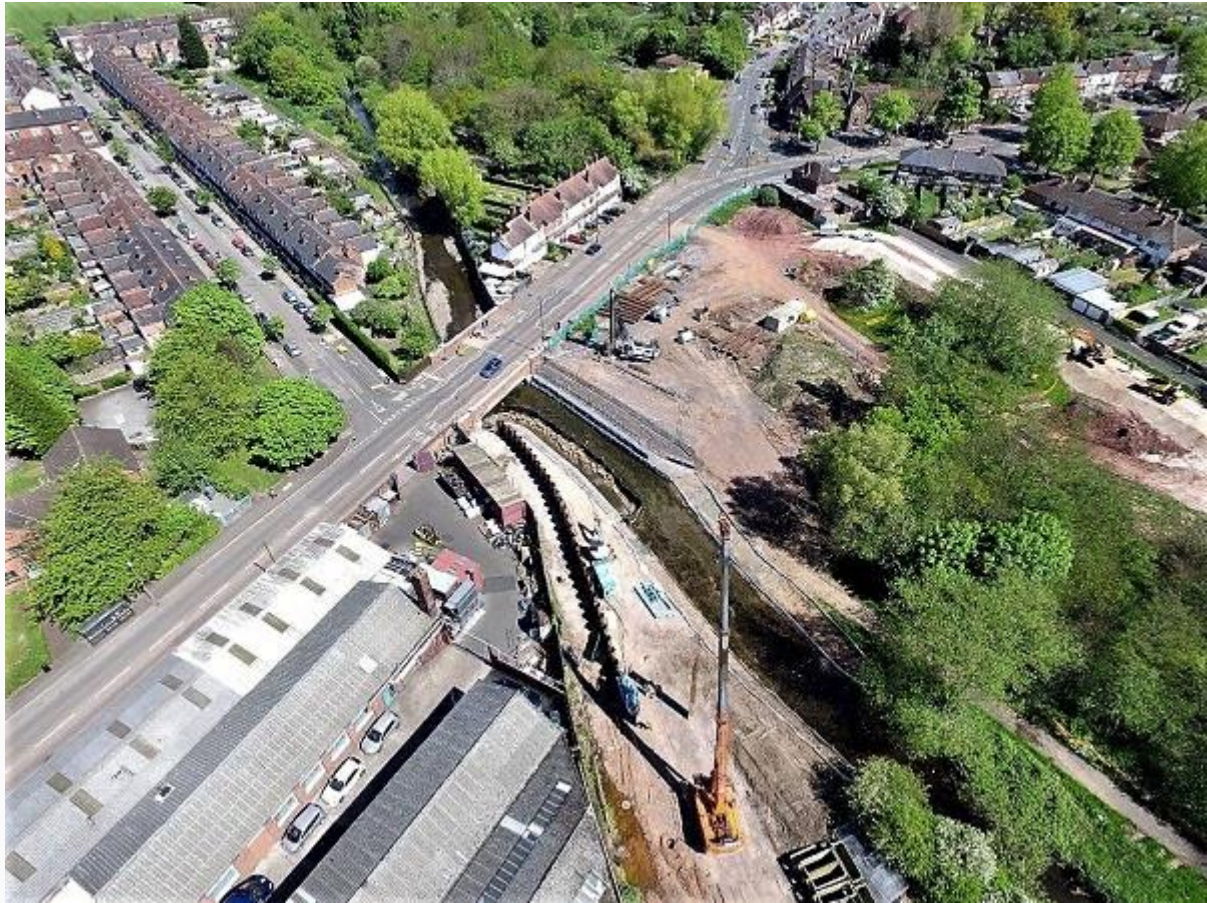
**The UPPER IMAGE shows the site viewed from the south west.**

Dogpool Bridge is in the centre of the image and the sheet piling work on the western (left) bank is visible. Over to the right the recent construction work on the Ashbrtook Road bund is visible.

**PROGRESS REPORT Monday 22nd May:** On the western bank of the river sheet piling for the core of the flood defence wall is complete and concrete foundations are being laid for brick cladding, which will make up the face of the wall. Further upstream a flood defence embankment (bund), which will continue on from the wall, is being built. On the eastern side the bund running parallel with the rear of Ashbrook Road is built and the topsoil is drying out ahead of stone removal and seeding with grass. Downstream from the bridge preparation is taking place for the building of concrete flood defence walls.

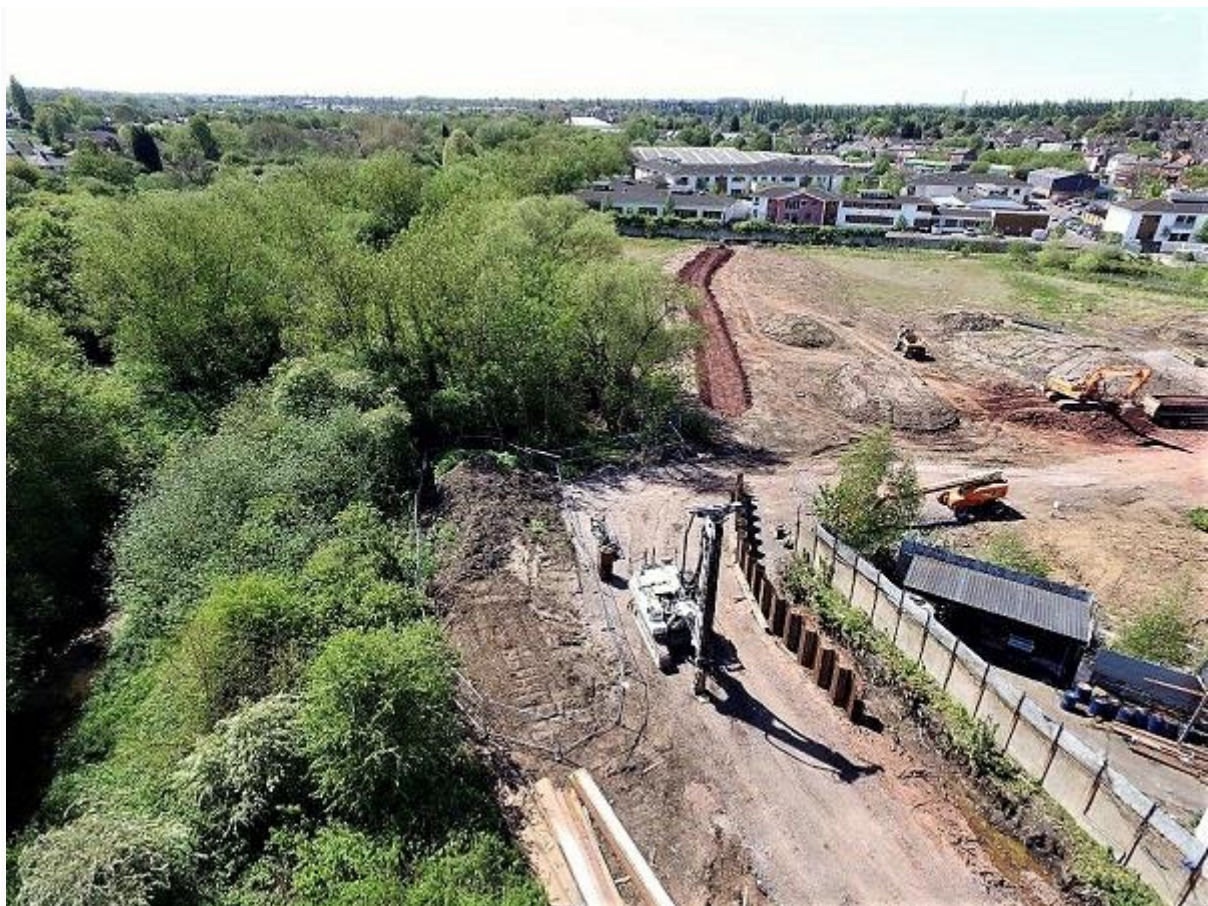
**The LOWER IMAGE shows the site viewed from the north.** The River Rea is running between the trees on the left. The existing St Andrews Healthcare buildings are visible in the background. Western bank sheet piling can be seen in the foreground and the under-construction western bund can be seen extending towards the buildings.
