# SELLY PARK SOUTH FLOOD RISK MANAGEMENT SCHEME 2017-18

## Work is starting on the Environment Agency's £2.4 million flood risk management scheme in Selly Park South

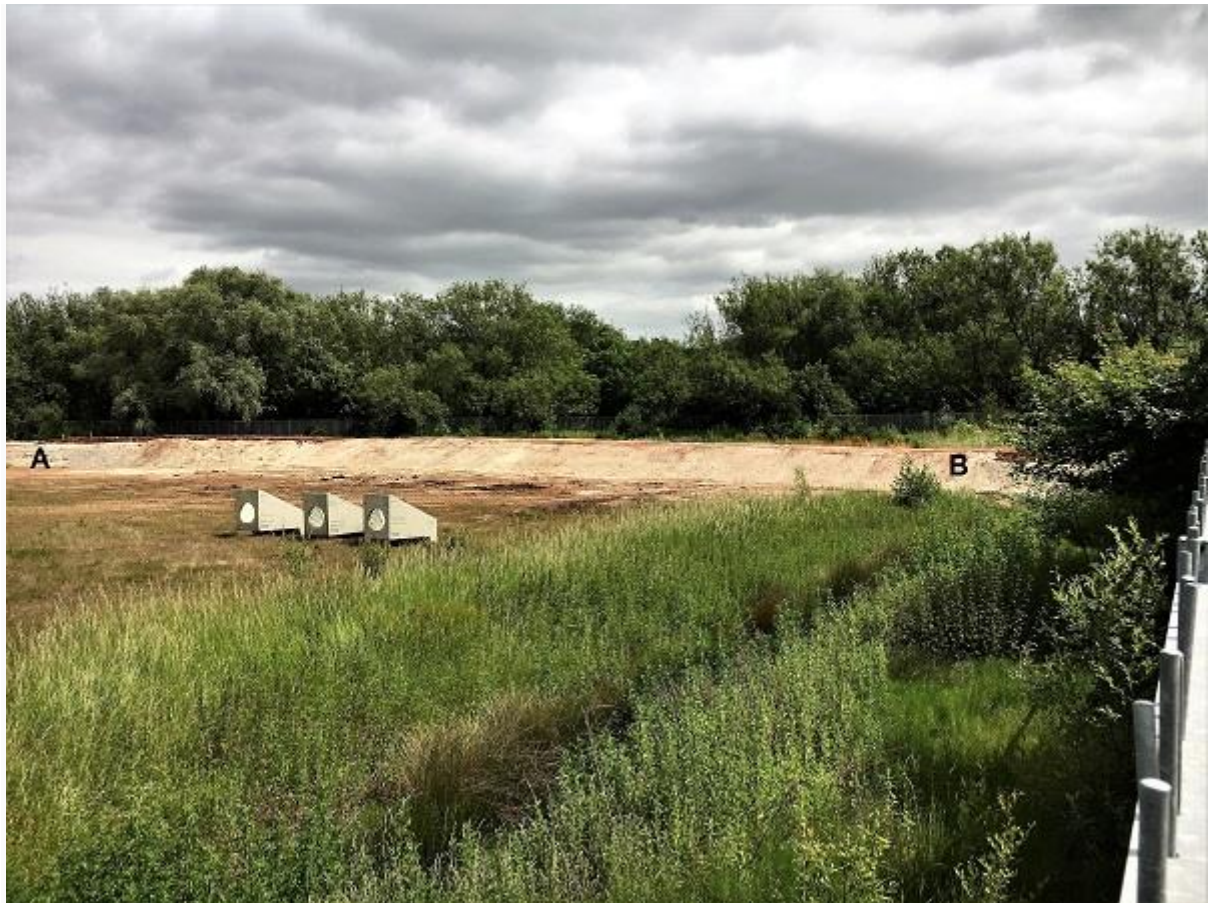
**The upper image** shows the bund (flood defence embankment) running from near Leakes factory (A) to St Andrews Healthcare (B).

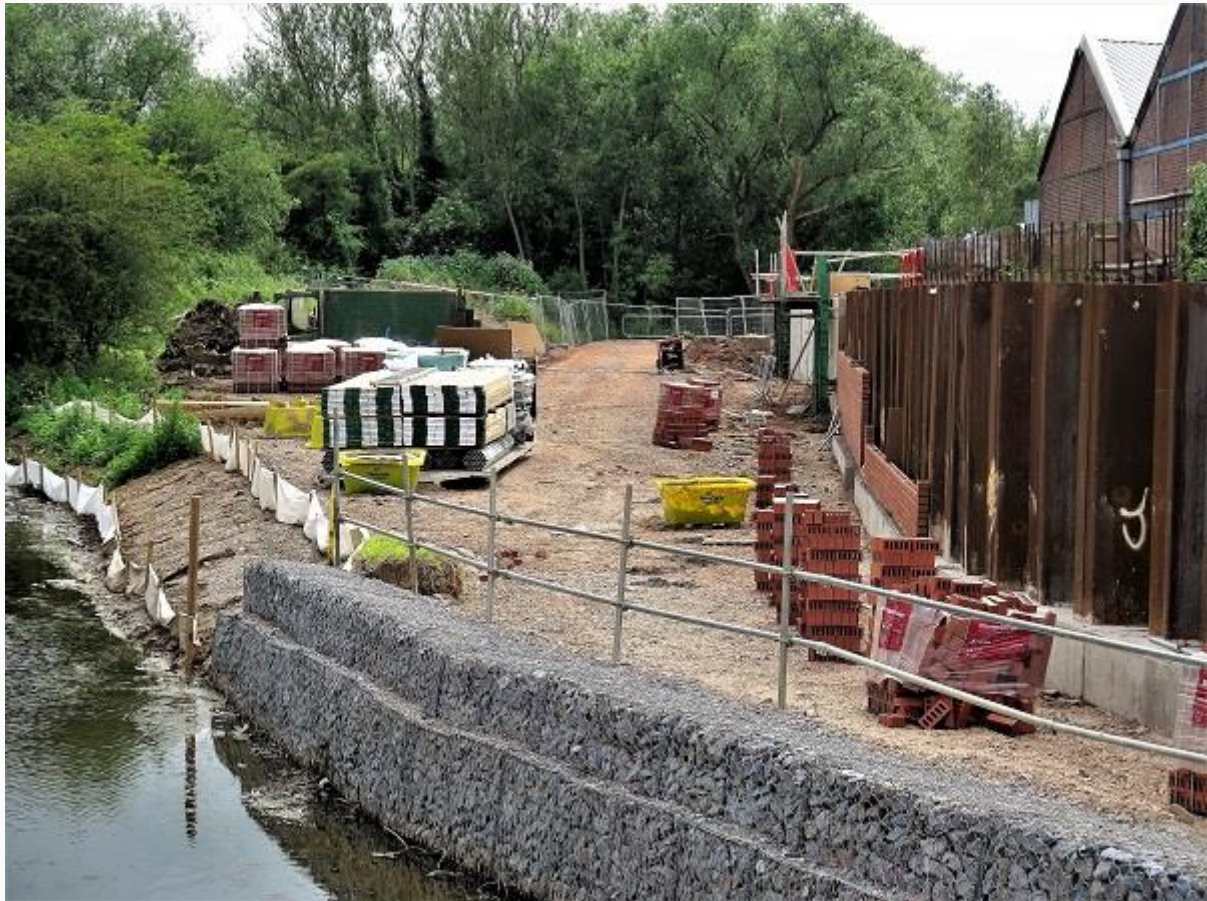
**The lower image** shows the sheet-piled flood defence wall adjacent to Leakes factory which is being clad with a brick fascia. These structures will cut off the flow route of flood water from the river which led to the serious flooding of Dogpool Lane, Fashoda Road, Cecil Road and nearby roads in 2008, 2012 and 2016.

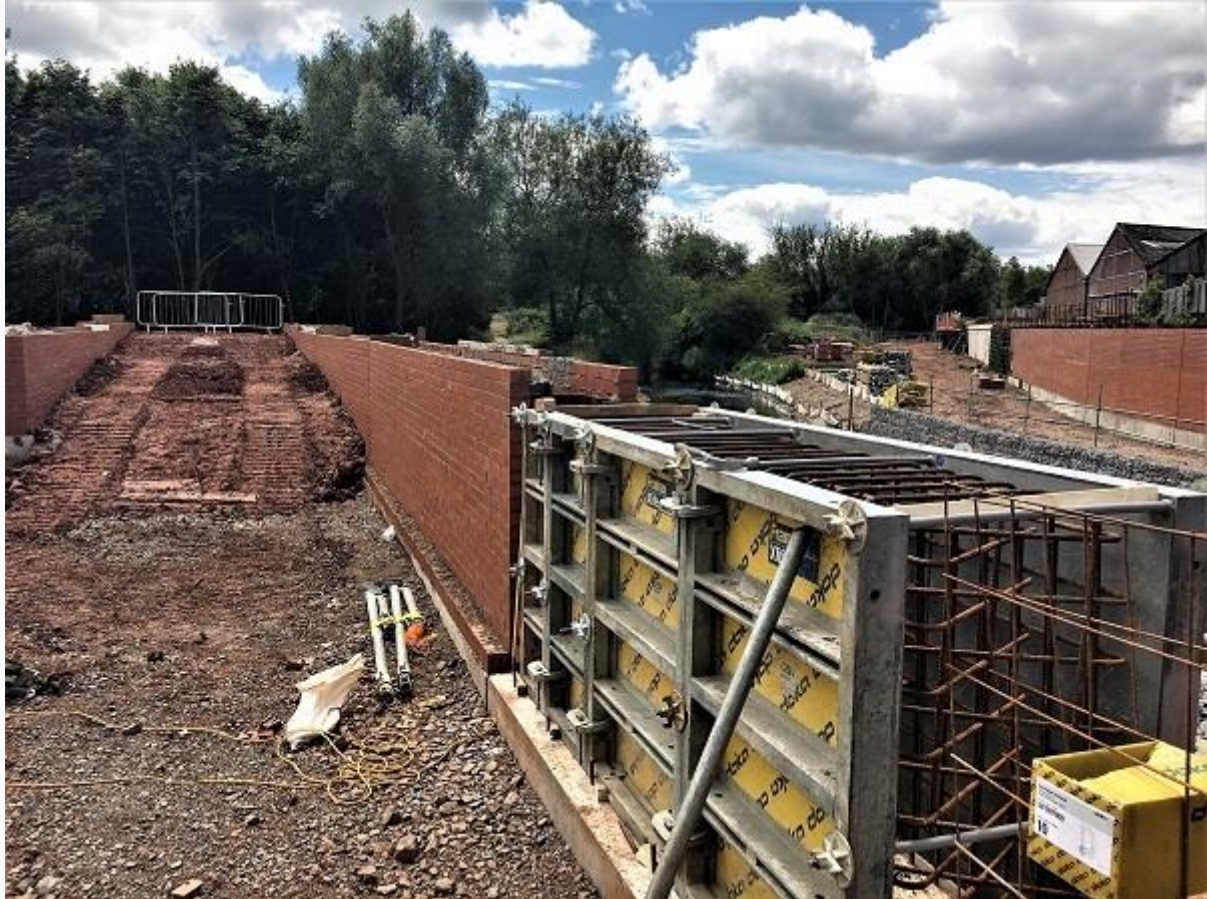
**PROGRESS REPORT Monday 3rd July: The image below shows the ramp which will take the Rea Valley cycle route and footpath over the Moor Green Lane bund (flood defence embankment).**

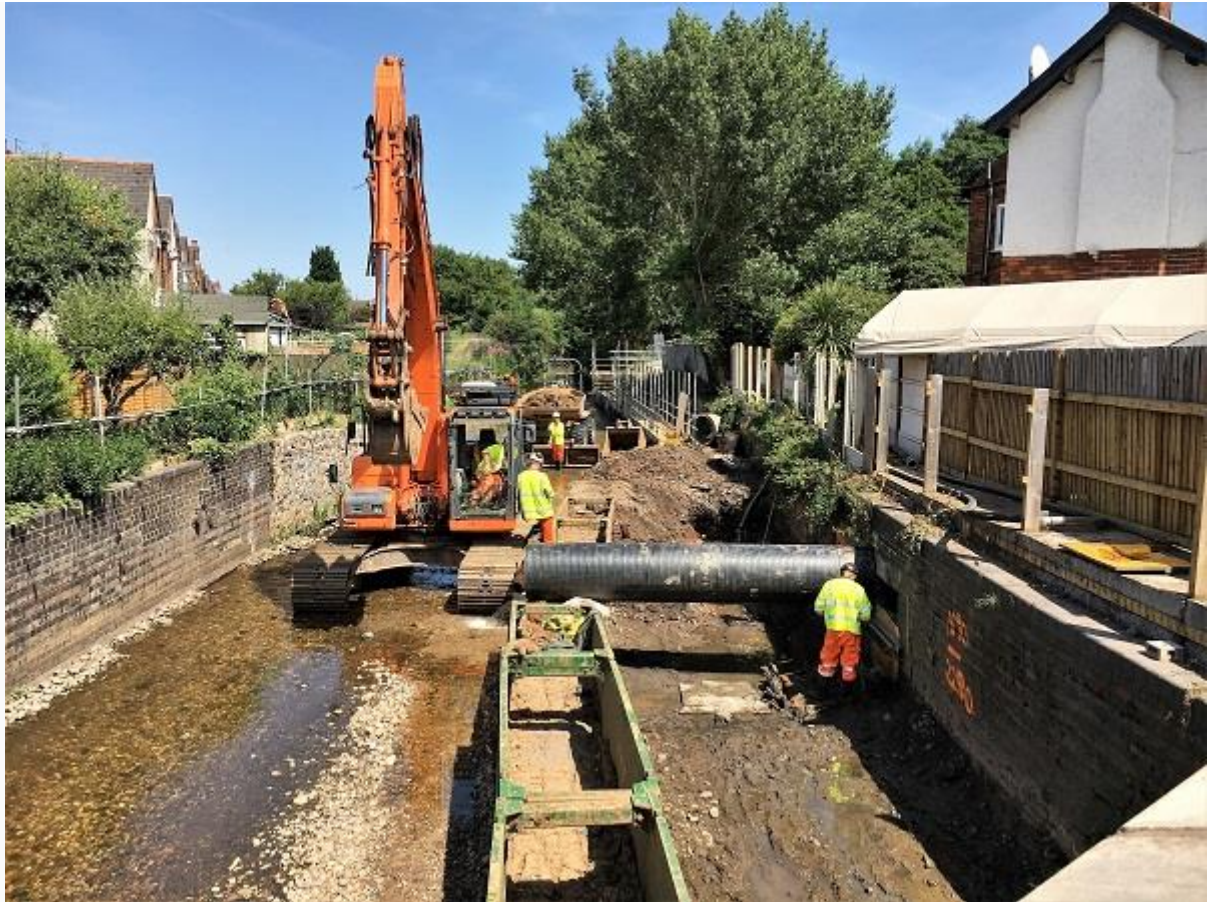
**The upper image** shows work starting on building the flood defence wall on the eastern side of the river downstream from the bridge.

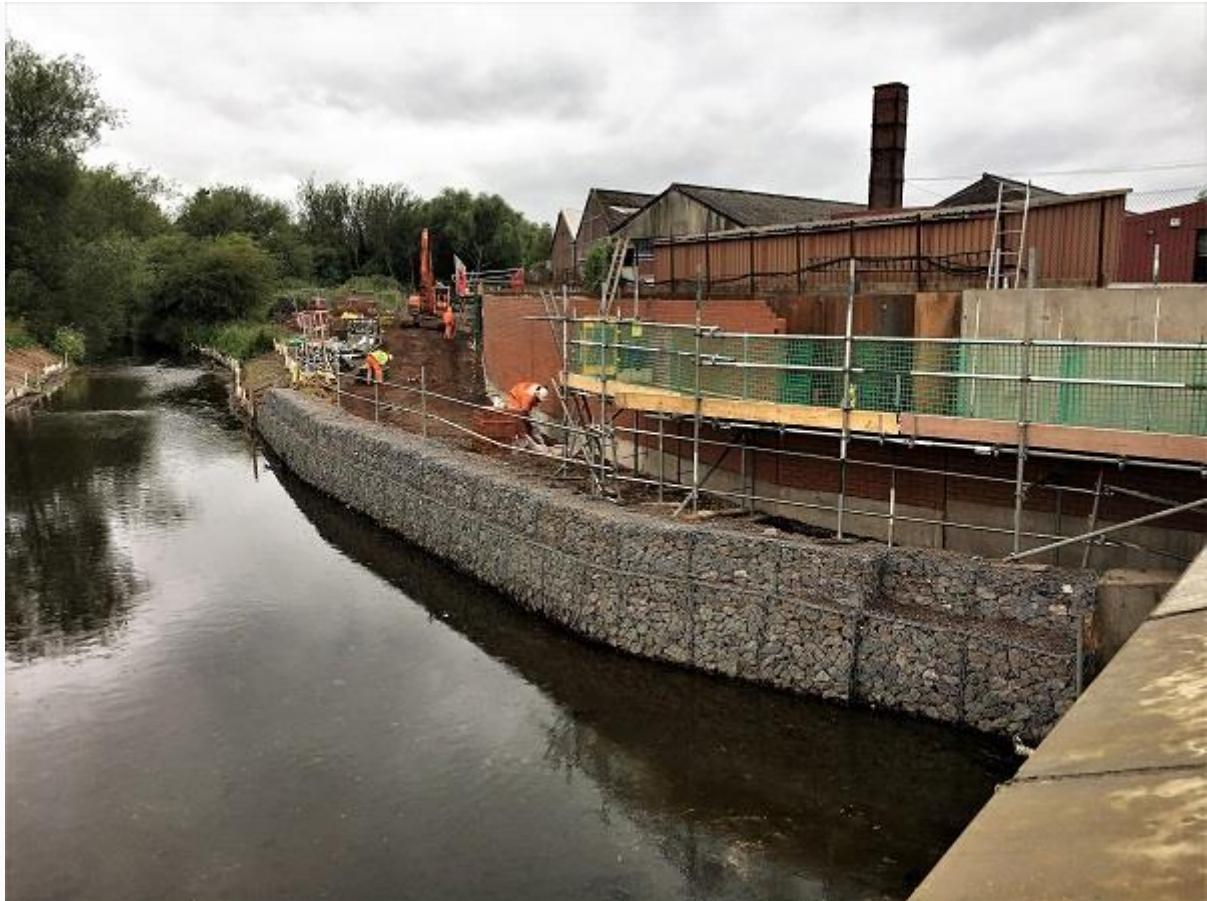
**The lower image** shows continuing work on the brick cladding of the flood defence walls upstream from the bridge. To view an image of the ramp which will take the cycle way and footpath over the flood defence embankment to the east of the bridge, please go to our [FEATURES PAGE](#) report for Monday 3rd July.

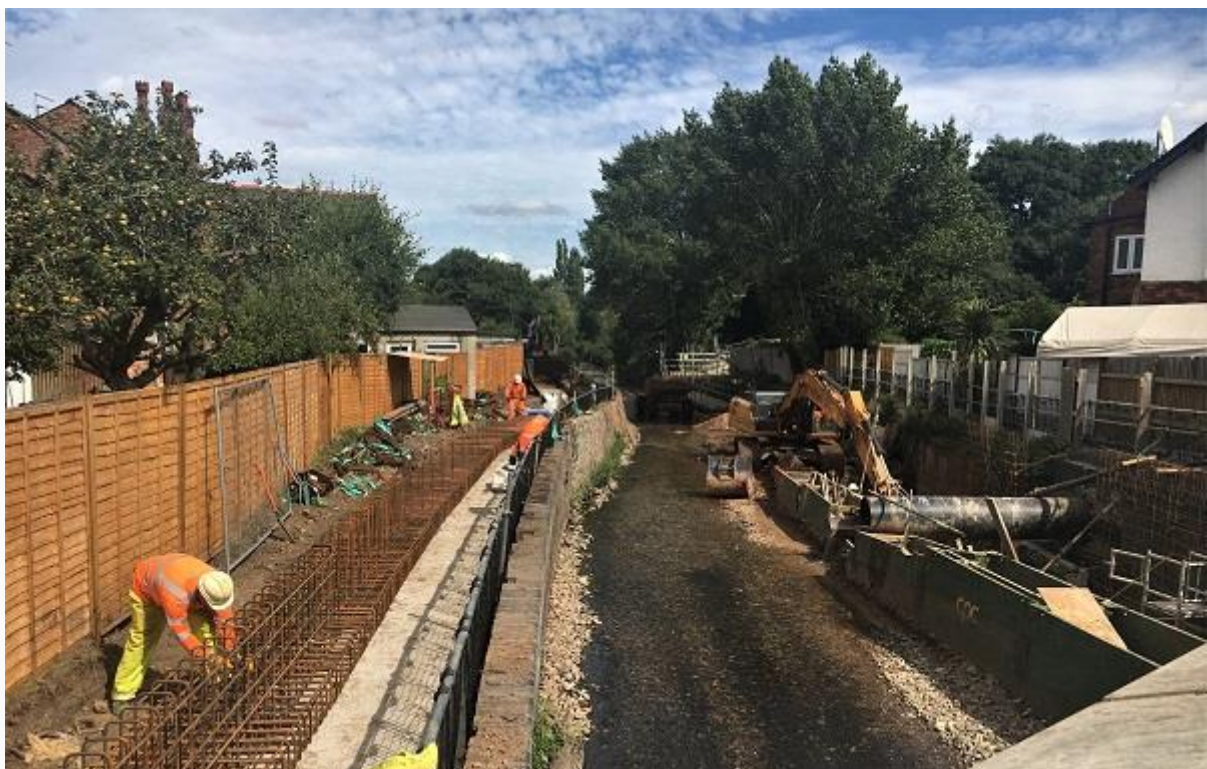
**The image shows the view from Dogpool Bridge, looking downstream, where work has started on constructing the foundations of flood defence walls on both sides of the channel.** The walls will rise to approx 1 metre above current bank top level and extend a few hundred metres downstream, protecting the properties on each side of the bank from being flooded by the river at times of extreme flow.

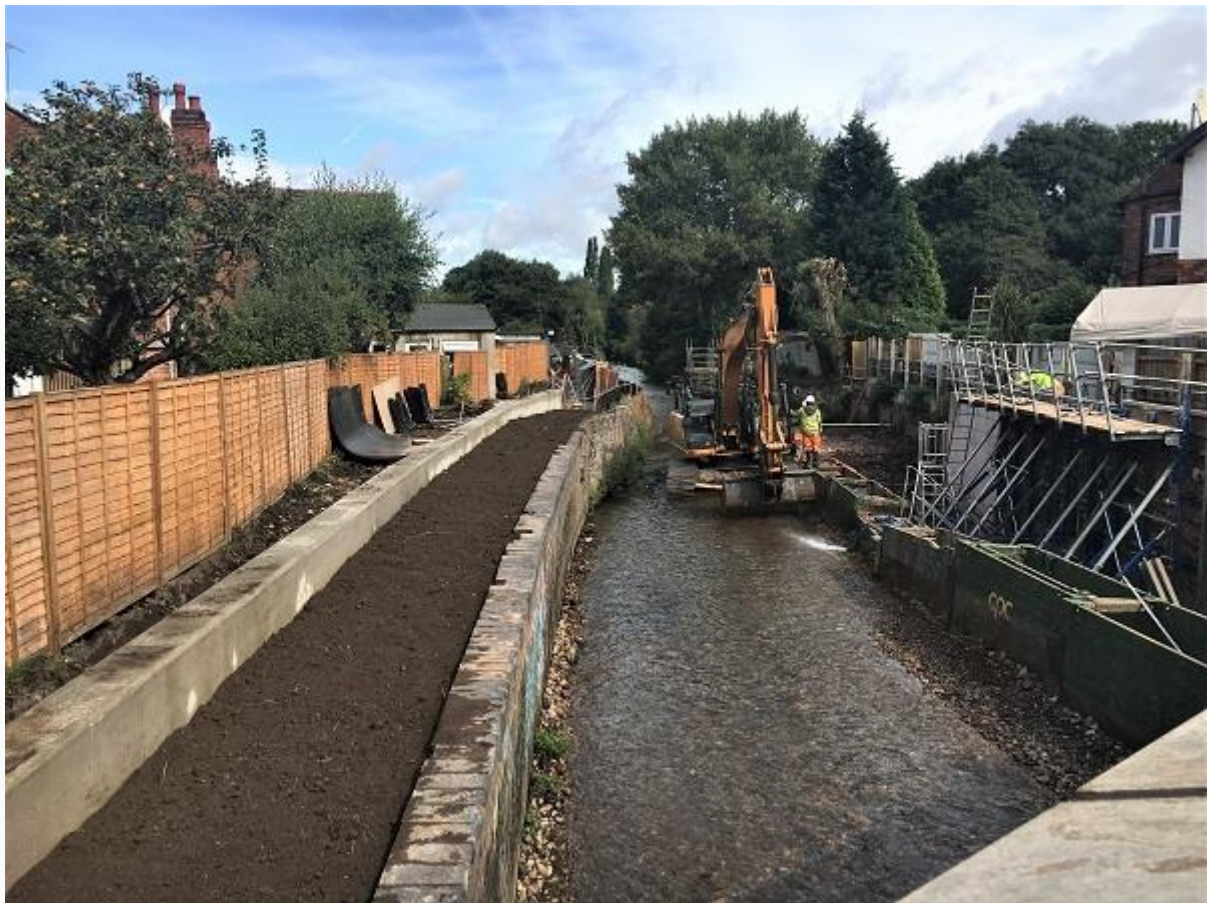
**The image above shows the view from Dogpool Bridge, looking downstream, where work is now well underway constructing flood defence walls on both sides of the channel.** The walls will rise to approx 1 metre above current bank top level and extend a few hundred metres downstream, protecting the properties on each side of the bank from being flooded by the river at times of extreme flow.

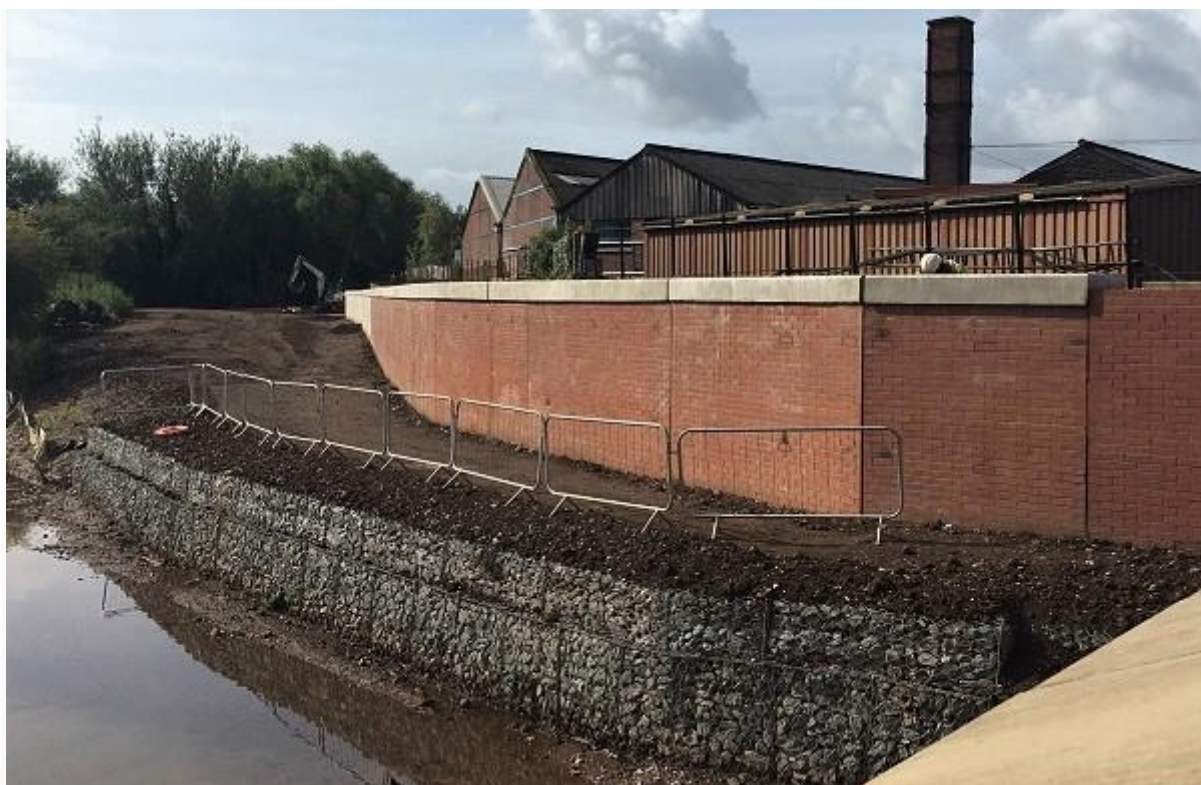
**The image below shows the view from Dogpool Bridge, looking upstream, where construction of the western flood defence wall is nearing completion.**

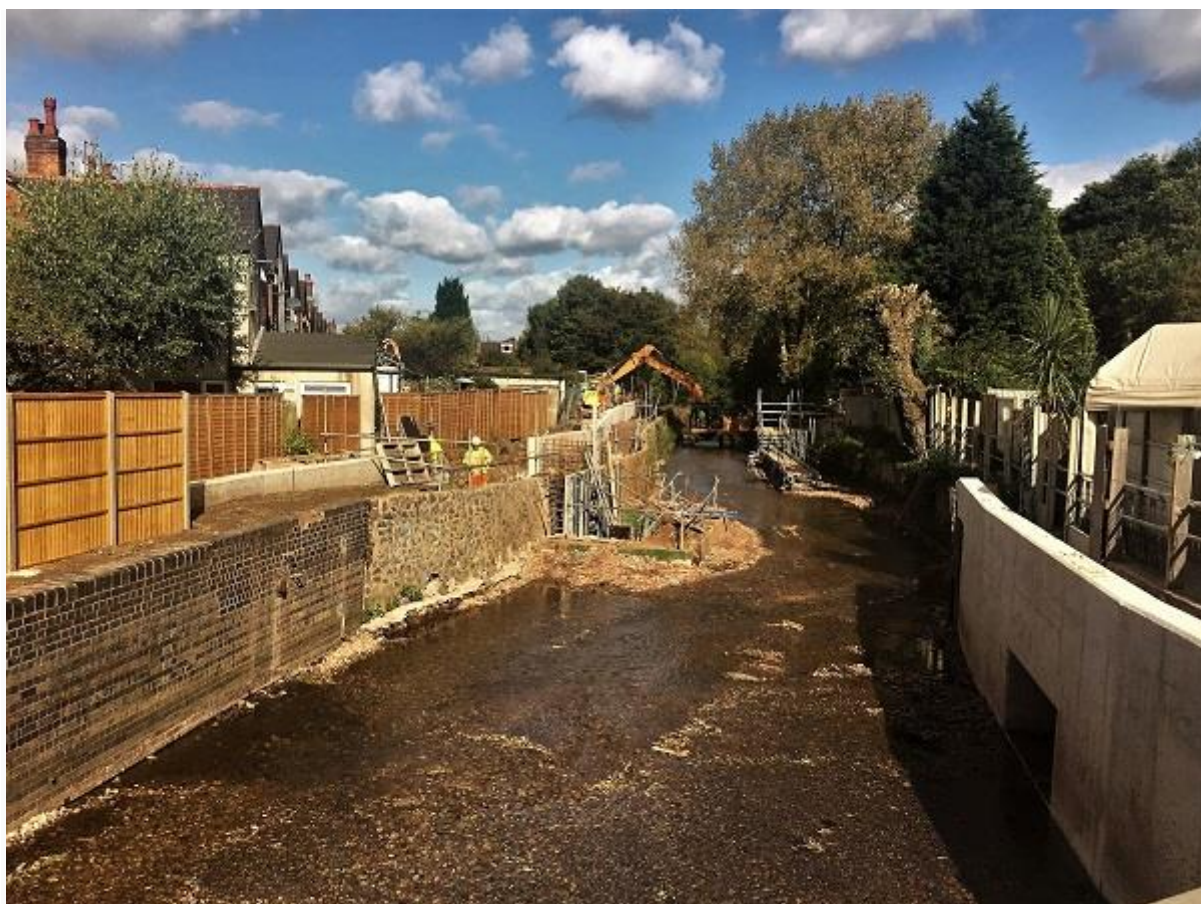
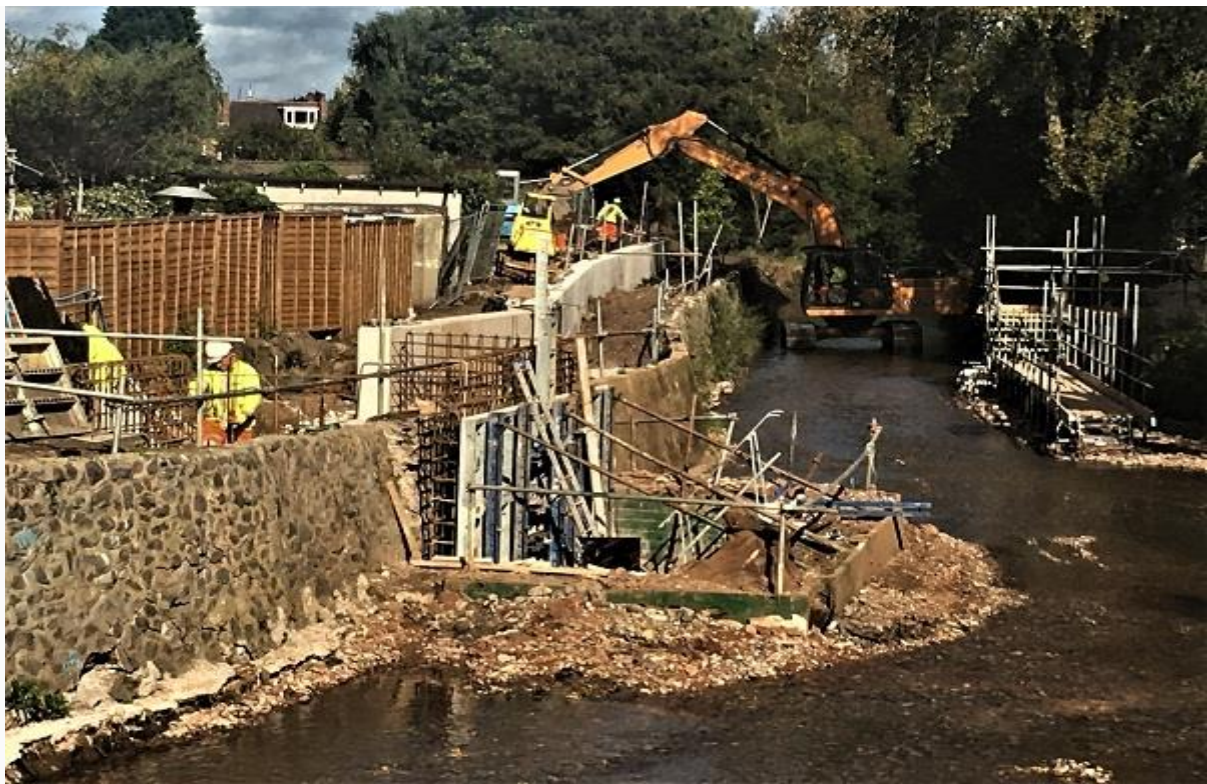
**The images show views from Dogpool Bridge, looking downstream, where work is currently concentrated on constructing flood defence walls on both sides of the channel, particularly at present on the Cecil Road side.** The walls will rise to approx 1 metre above current bank top level and extend a few hundred metres downstream, protecting the properties on each side of the bank from being flooded by the river at times of extreme flow. On the Cecil Road side new fencing is beginning to be erected at the bottoms of the gardens alongside the riverbank as part of the post-construction restoration work

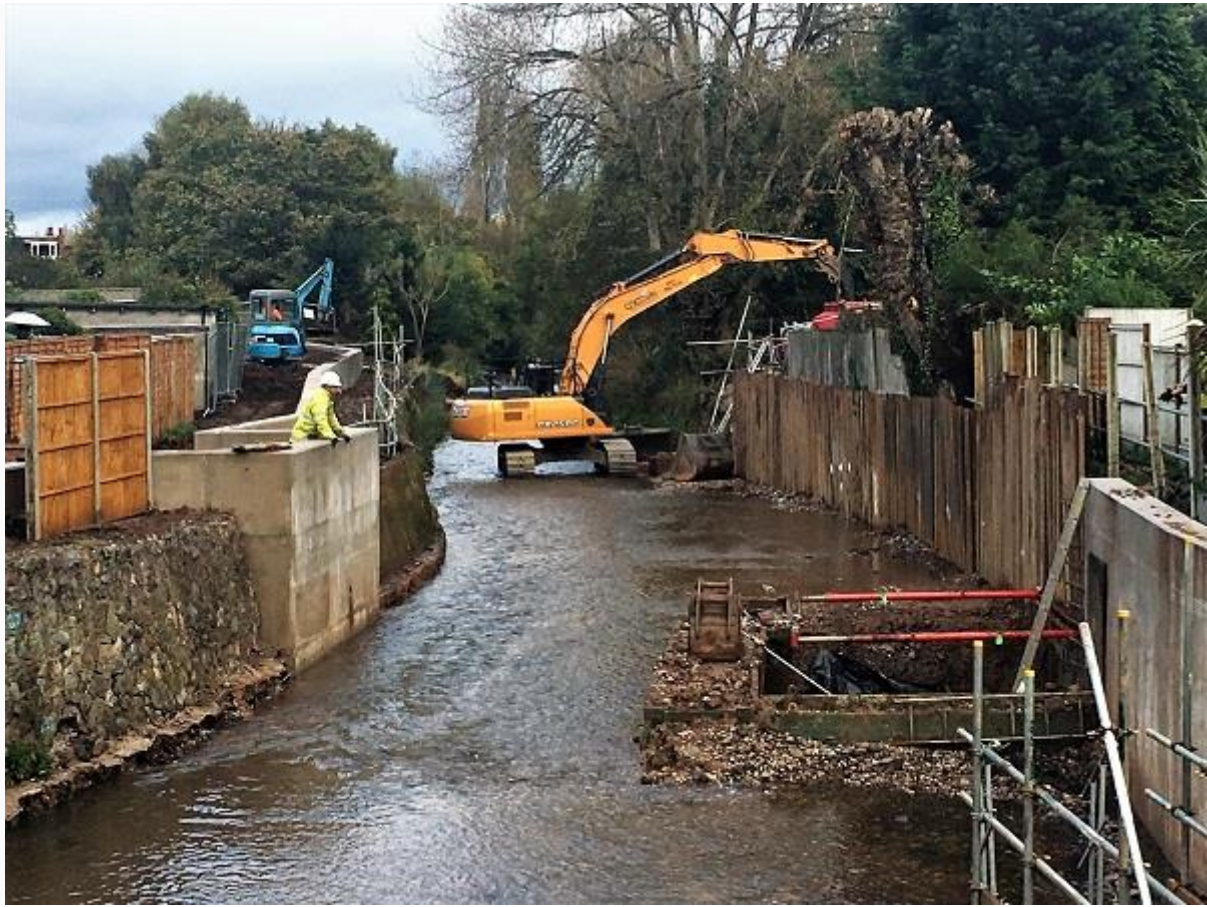
**The image shows views from Dogpool Bridge, looking downstream, where work is currently concentrated on constructing flood defence walls on both sides of the channel.** The walls will rise to approx 1 metre above current bank top level and extend a few hundred metres downstream, protecting the properties on each side of the bank from being flooded by the river at times of extreme flow. On the Cecil Road side new fencing is beginning to be erected at the bottoms of the gardens alongside the riverbank as part of the post-construction restoration work. **PROGRESS REPORT - 3rd November 2017:**

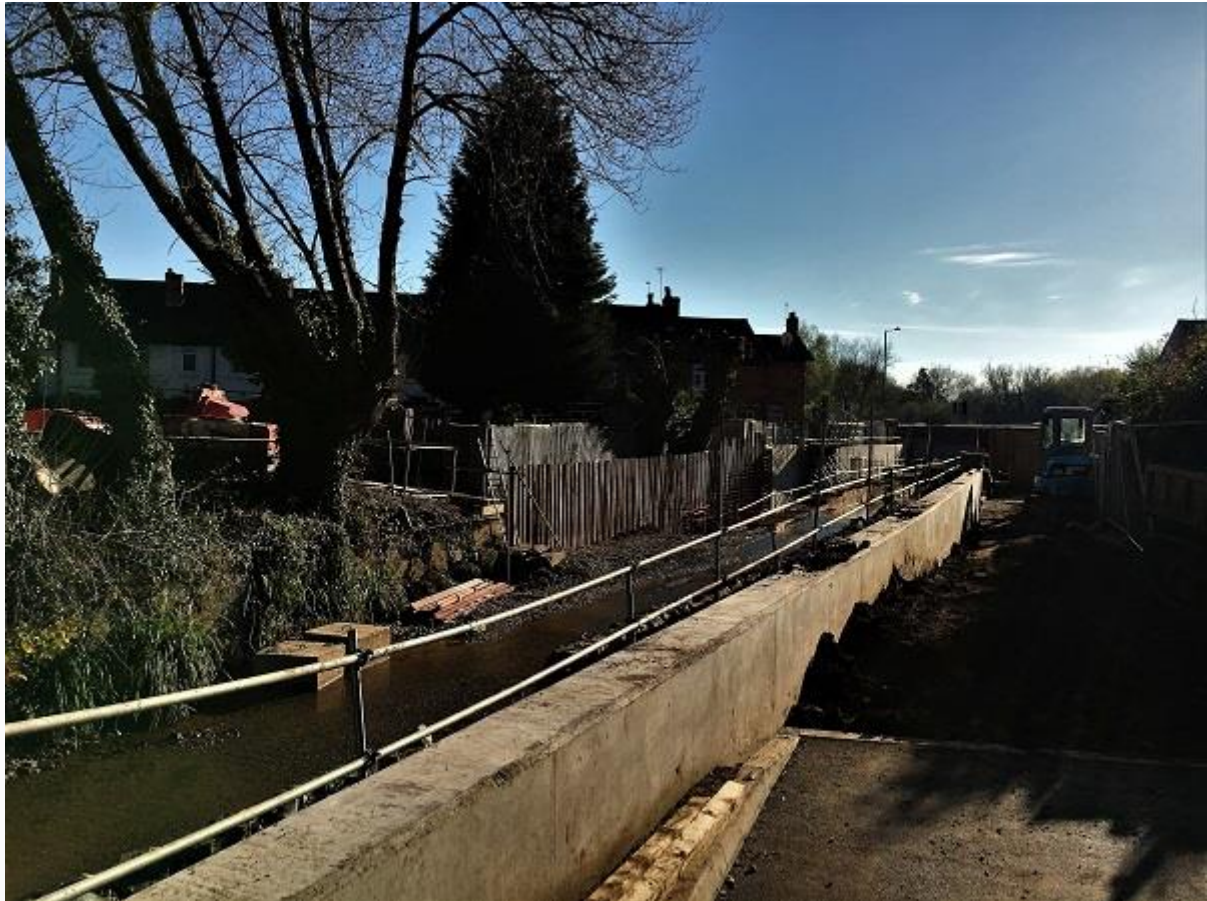
**The image shows the view downstream from Dogpool Bridge, looking south towards the bridge, where work is currently concentrated on building flood defence walls on both sides of the river channel.** The walls are being constructed to rise to an approximate maximum of 1 metre above current bank top level and extend a few hundred metres downstream, protecting the properties in Cecil Road (right) and Moor Green Lane (left) from being flooded by the river at times of extreme flow. On the Cecil Road side the flood defence wall is complete, and new fencing has been erected at the bottoms of the gardens alongside the riverbank as part of the post-construction restoration work for residents. Meanwhile the final major stage of construction is focussed on building the poured concrete reinforced flood defence wall on the Moor Green Lane side.

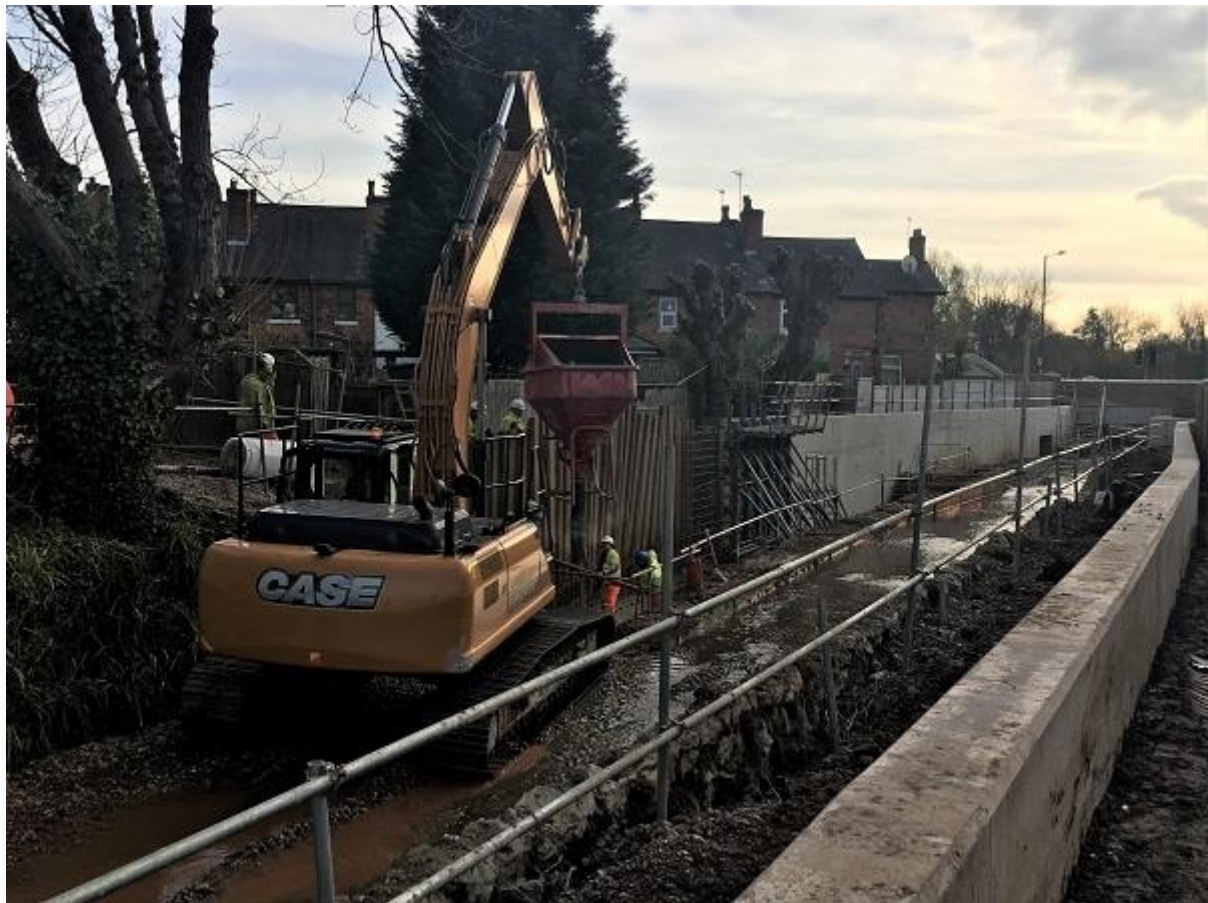
**The image shows the view upstream towards Dogpool Bridge.** The building of the flood defence wall on the Cecil Road side (right) has been completed as has much of the construction of the flood defence wall on the Moor Green Lane side (left). Work continues on the remaining section of this wall where concrete pouring is currently taking place.

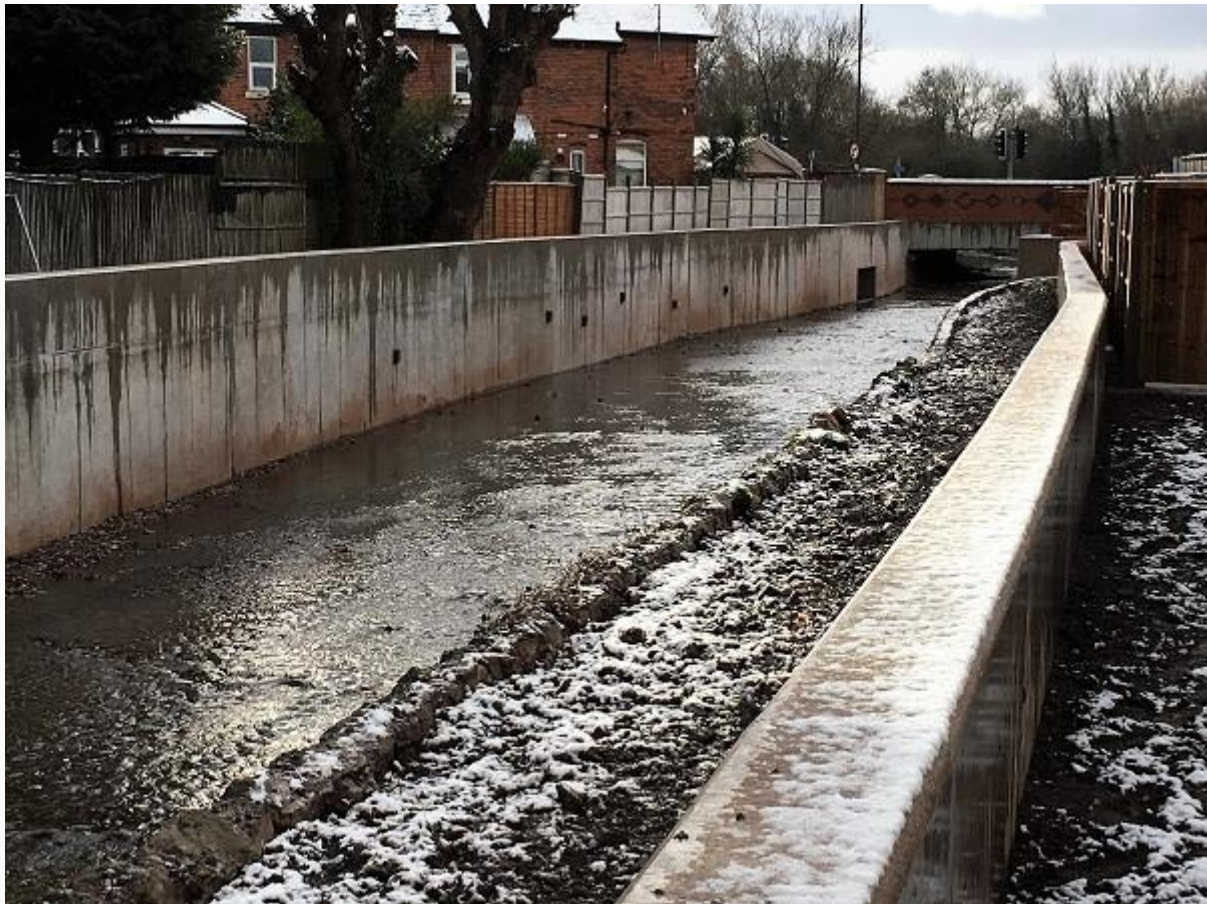
**The image shows the view upstream towards Dogpool Bridge. The building of flood defence walls between the rear of Cecil Road and Moor Green Lane is now completed which marks the end of the main construction phase of the FRMS, meaning that the scheme is fully operational.** Some remaining minor construction works will be completed in the coming weeks and during the first half of 2018 land restoration work on the southern side of Moor Green Lane will be carried along with ensuring that the grass seeding of the flood defence embankments has been successful. It is expected that there will be an official opening ceremony for the scheme early in the New Year. The scheme has been carried out by the Environment Agency, working alongside St Andrew's Healthcare and Birmingham City Council as part of the Rea Catchment Partnership. To visit their website please [HERE](#). Further information specific to Selly Park South FRMS can be found by selecting the Current Projects menu.

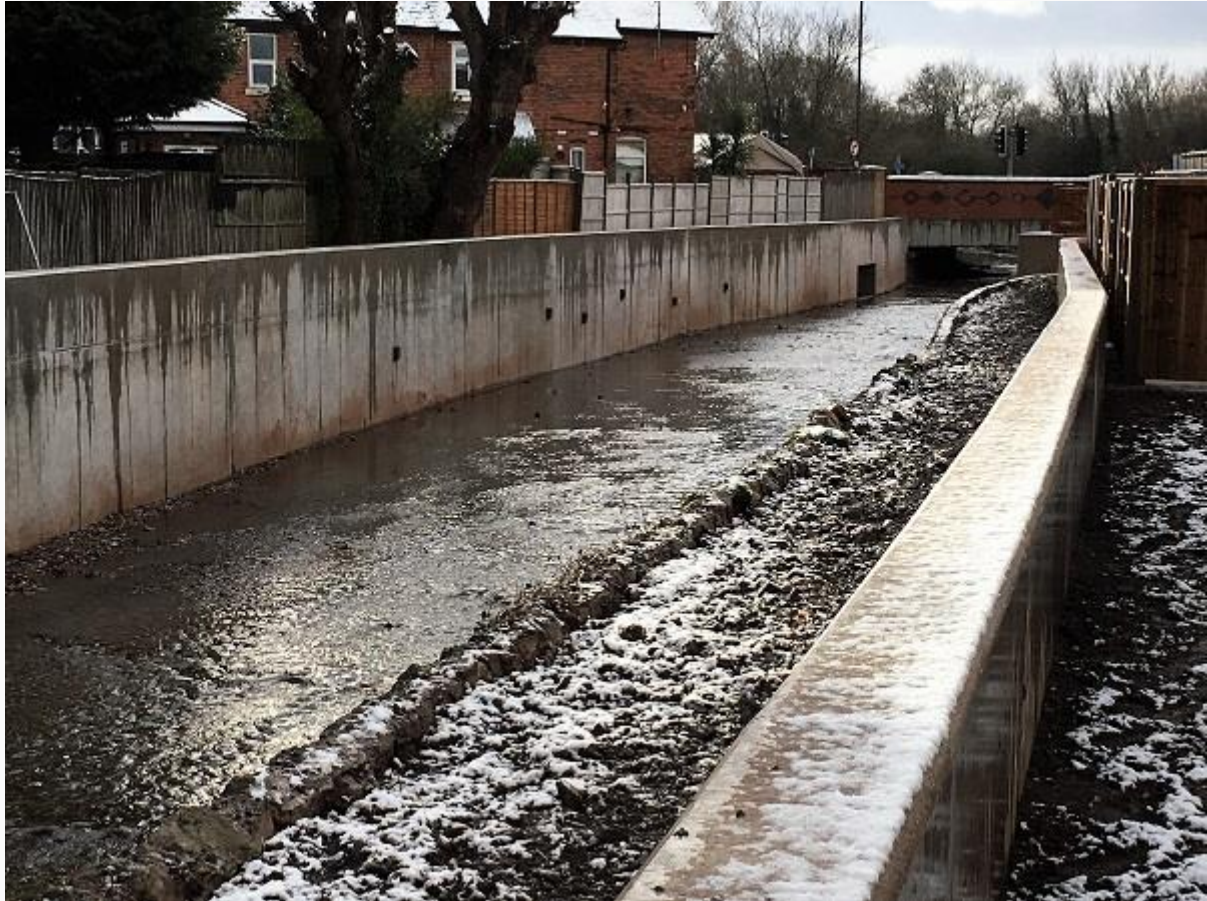
**The image shows part of the Selly Park South Flood Risk Management Scheme (FRMS), viewed upstream towards Dogpool Bridge. The building of flood defence walls between the rear of Cecil Road and Moor Green Lane is now completed which marks the end of the main construction phase of the FRMS, meaning that the scheme is fully operational reducing the risk of river**
